Technical Memorandum

Blum Junk Yard Properties

Assessment of Environmental Risk Related to Demolition of
Properties at 411 and 501 E. 15th Street

9/16/15

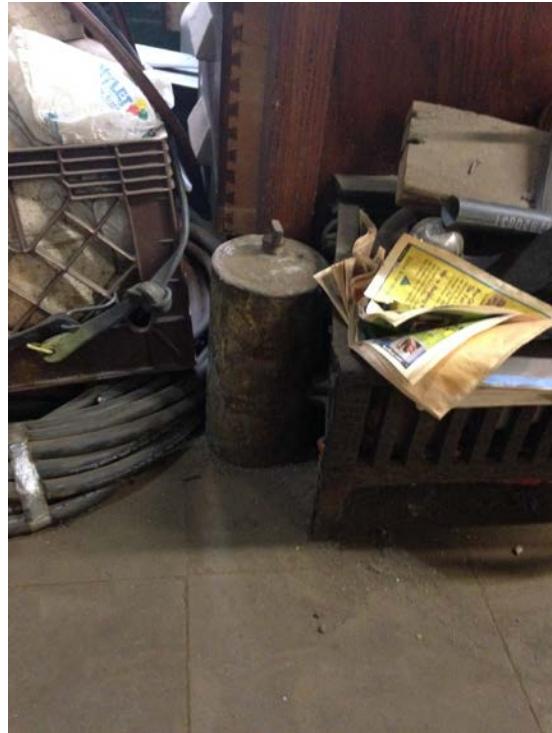
1. Seven to eight 76-pound steel flask shipping containers of liquid mercury were observed in the first-floor office space of the building on the 411 E. 15th St. property. One container was segregated from the others in the main office space, while the remaining six to seven containers were located in an adjacent storage room. The containers were observed to be corroded and rusty, and Mr. Blum reported that they are secured with a "finger-tight" seal. HR Green contacted the manufacturer of these containers (Bethlehem Apparatus) to obtain current storage and shipping specifications. According to the manufacturer, the containers should be free of external corrosion and rust with the bung screws securely fastened (see photos 1 and 2). The manufacturer indicated "finger-tight" bung screws and visible external container corrosion could indicate a dangerous situation where mercury vapor is off-gassing to the surrounding environment. Secondary containment and engineering controls to prevent personnel exposure were not present. Based on previous environmental site assessment records provided, interior mercury contamination has not been assessed on either property.

Photo 1 – View of mercury container in Mr. Blum's office.

- **Pre-demolition:**
 - Mercury vapor air monitoring of the entire facility and physical removal of liquid mercury containers from property.
 - Obtain samples from areas containing potential TEH, RCRA Metals, SVOC, and PCB contamination. These areas include, but are not limited to, the basement and the fourth floor of the main office building. Should exceedances of Iowa DNR Statewide Standards be identified, appropriate TCLP analyses will be conducted to determine appropriate disposal methods.

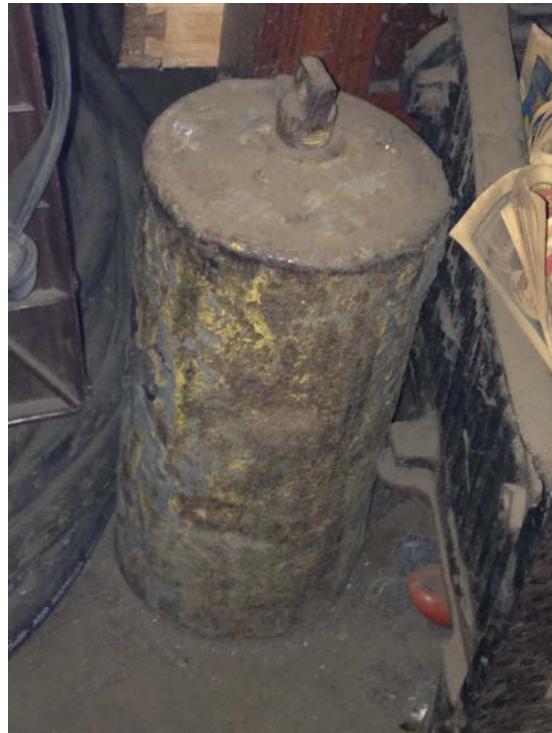
Photo 2 –Close up view of mercury container.

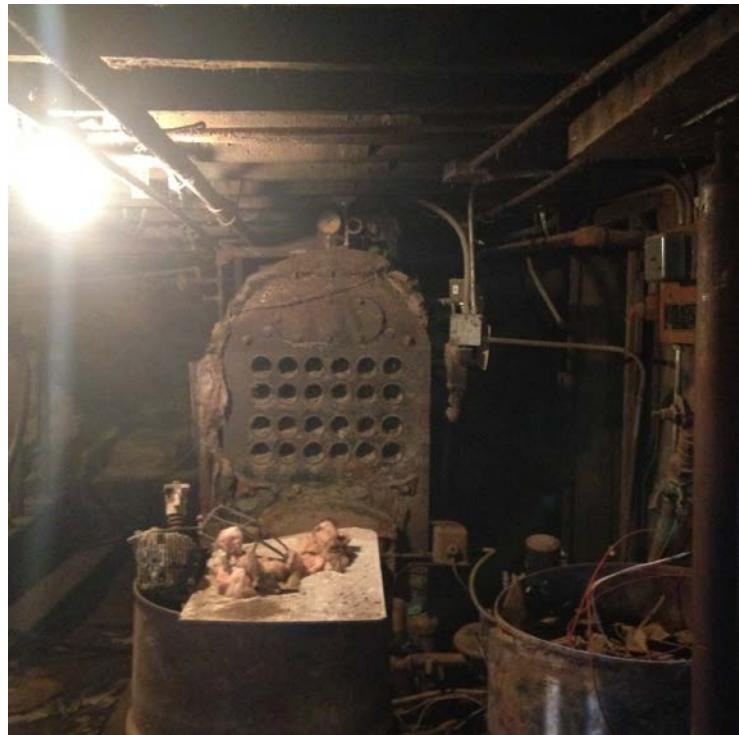
Photo 3 – Steam boiler wrapped in fiberglass insulation in basement in the main office building.

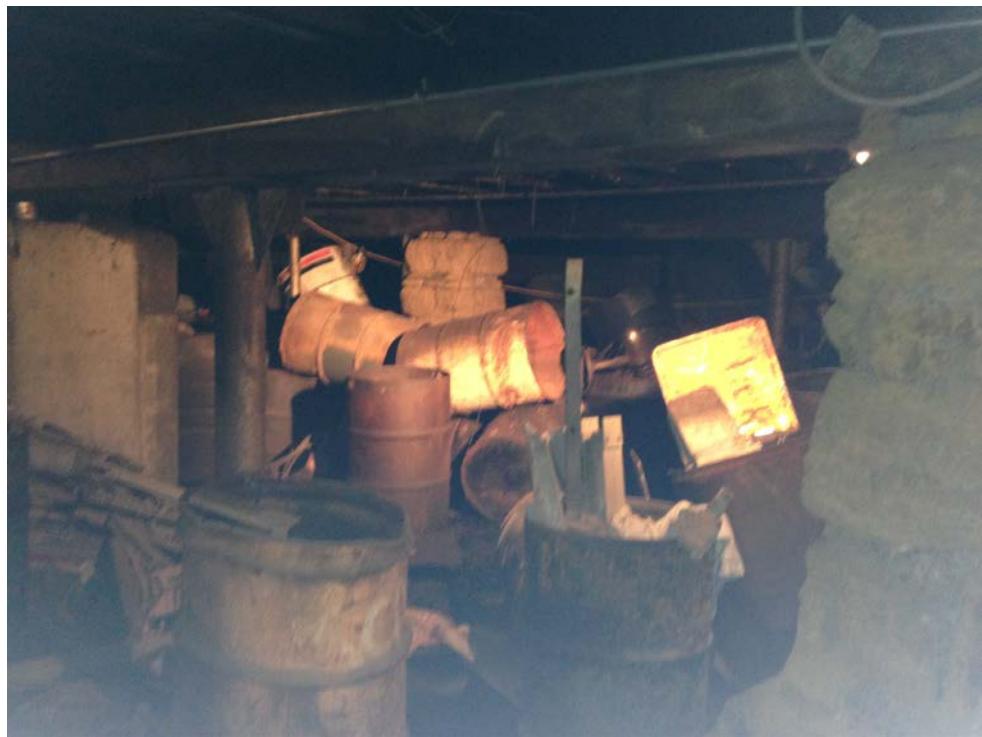
Photo 4 – View of physical state of basement in the main office building.

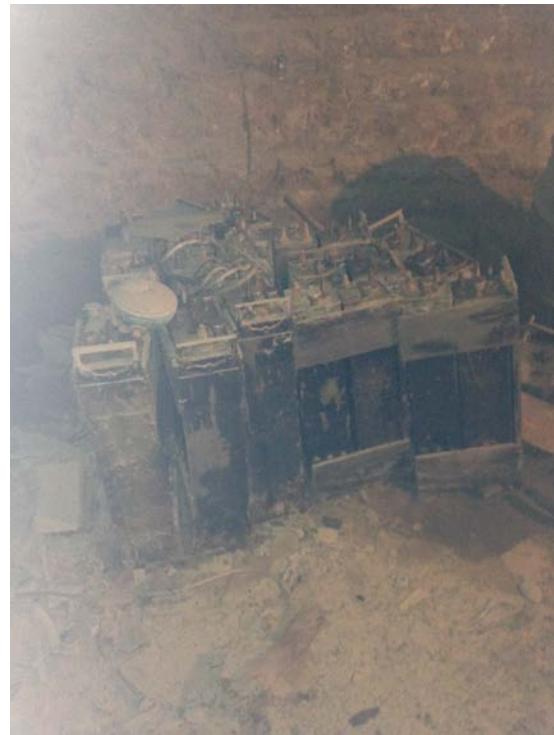
Photo 5 – View of batteries located on the south side in basement of the main office building.

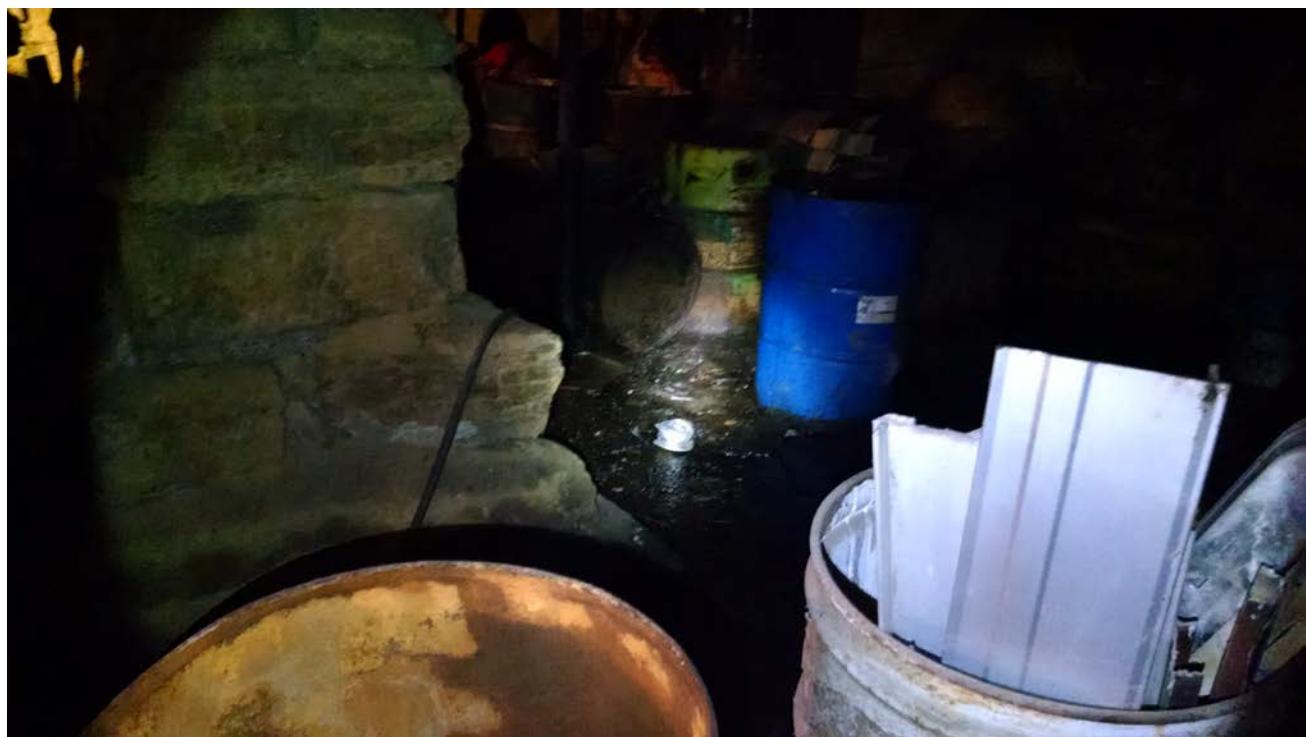
2. HR Green observed a large apparent chemical spill (likely petroleum-based hydraulic fluids) in the basement of the main office building located on the 411 E. 15th St. property. HR Green staff estimated the spill extent is at least 15' x 15', but the amount of other materials stored in the area prevented a more detailed assessment. According to Mr.

Blum, the on-going source of the spill is from the baler located on the first floor; this equipment has been in operation since 1968 until present day (see photos 6 and 7). It is not known if the hydraulic fluids used by this equipment contain hazardous components such as PCBs. Additionally, multiple suspected lead-acid batteries and at least one likely PCB transformer, all badly deteriorated, were located in the basement of the office building (see photos 5 and 8). No visible secondary containment was present. The owner commented that the basement had been flooded several times (the owner noted the flooding had reached the height of the 1st floor joists) and residual soil and other debris likely covered the entire basement cement floor. Based on previous environmental site assessment records provided, basement potential polychlorinated biphenyls (PCB), total petroleum hydrocarbon (TEH), semi-volatile organic compound (SVOC), and all RCRA metals contamination has not been assessed.

Photo 6 – View of large spill from the baler (main level) in basement of the main office building.

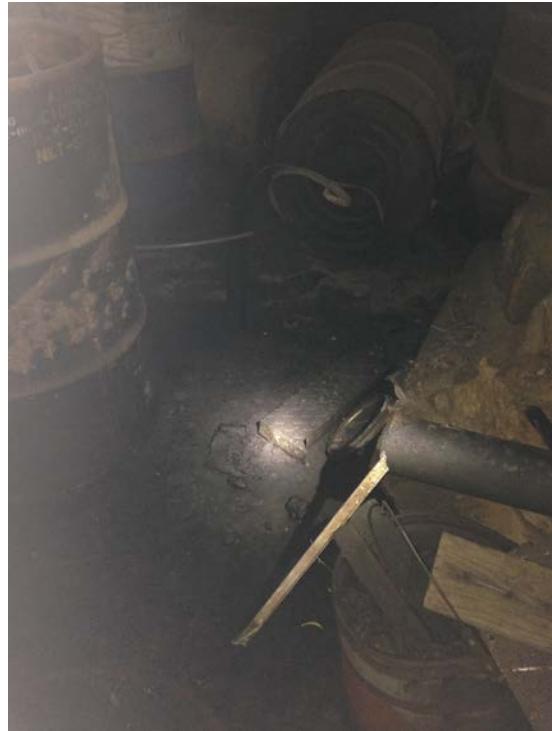
Photo 7 – View of large spill from the baler (main level) in basement of the main office building.

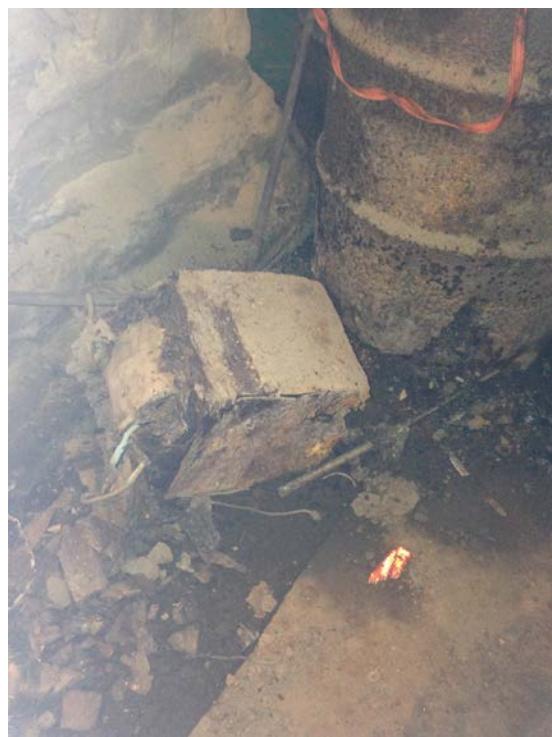
Photo 8 – View of corroded transformer in basement of the main office building.

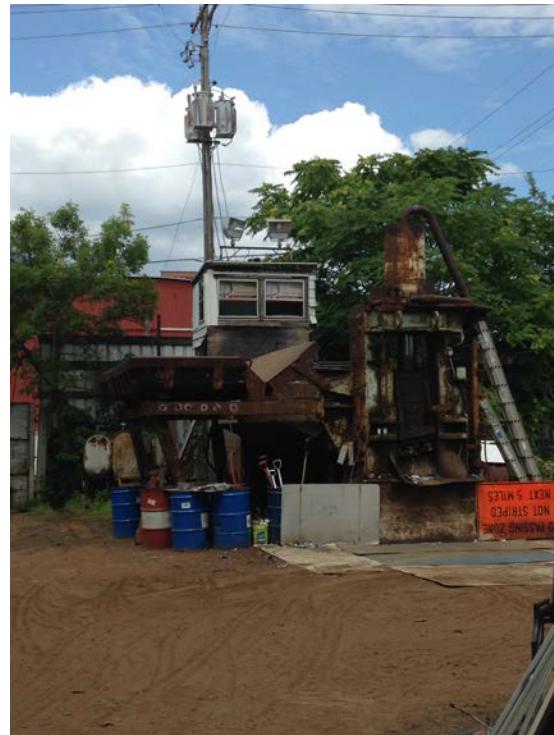
5. HR Green observed several areas of staining around the crusher and inside the control room located next to the crusher, as well as other equipment on the outside grounds located north of the main office building (see photos 10-13; 17-19). It is not known if the hydraulic fluids used by this equipment contain hazardous components such as PCBs. Based on previous environmental site assessment records provided, TEHs, arsenic, chromium, and lead have been assessed in several locations on the grounds. Based on previous environmental site assessment records provided, this area has not been assessed for other RCRA Metals or PCBs.

Photo 10 – View of crusher and operator building located on the grounds of the west side property.

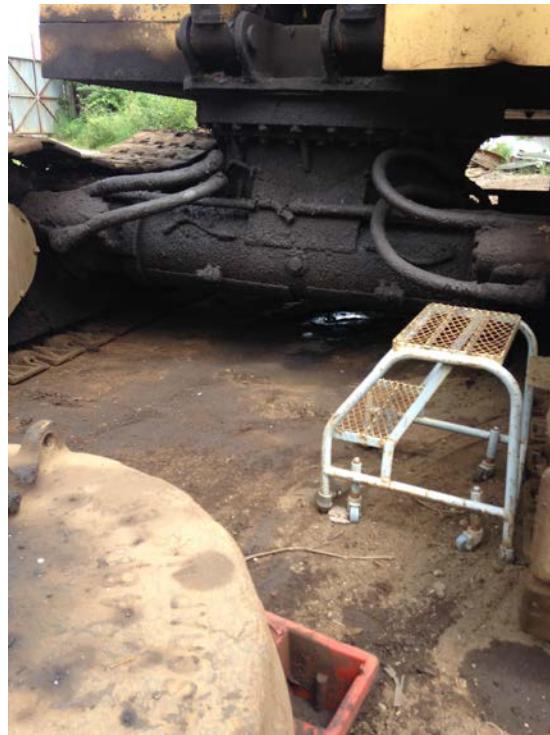
Photo 11 – View of staining under equipment located on the grounds of the west side property.

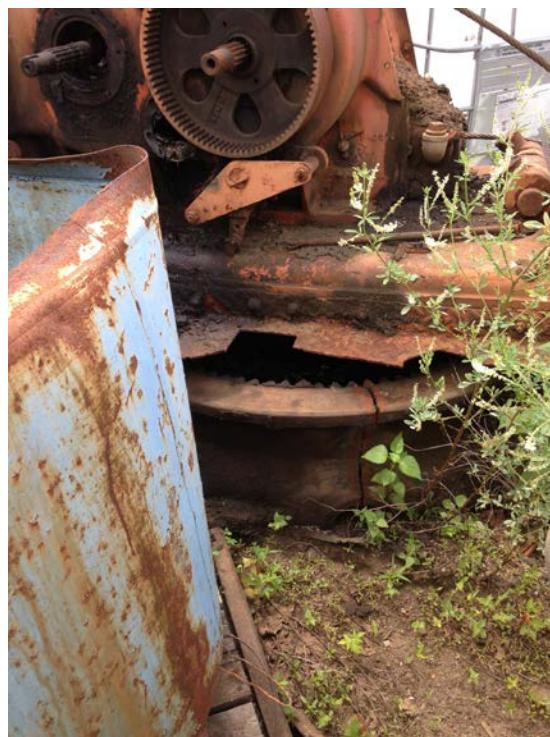
Photo 12 – View of staining under equipment located on the grounds of the west side property.

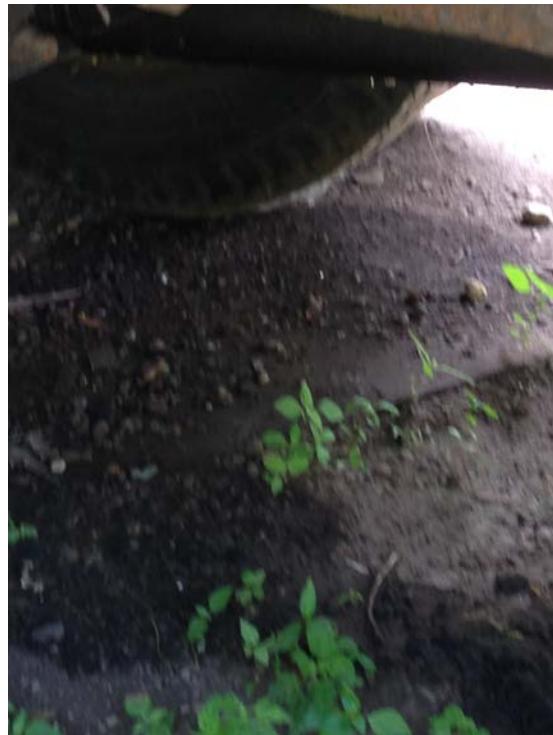
Photo 13 – View of staining under equipment located on the grounds of the west side property.

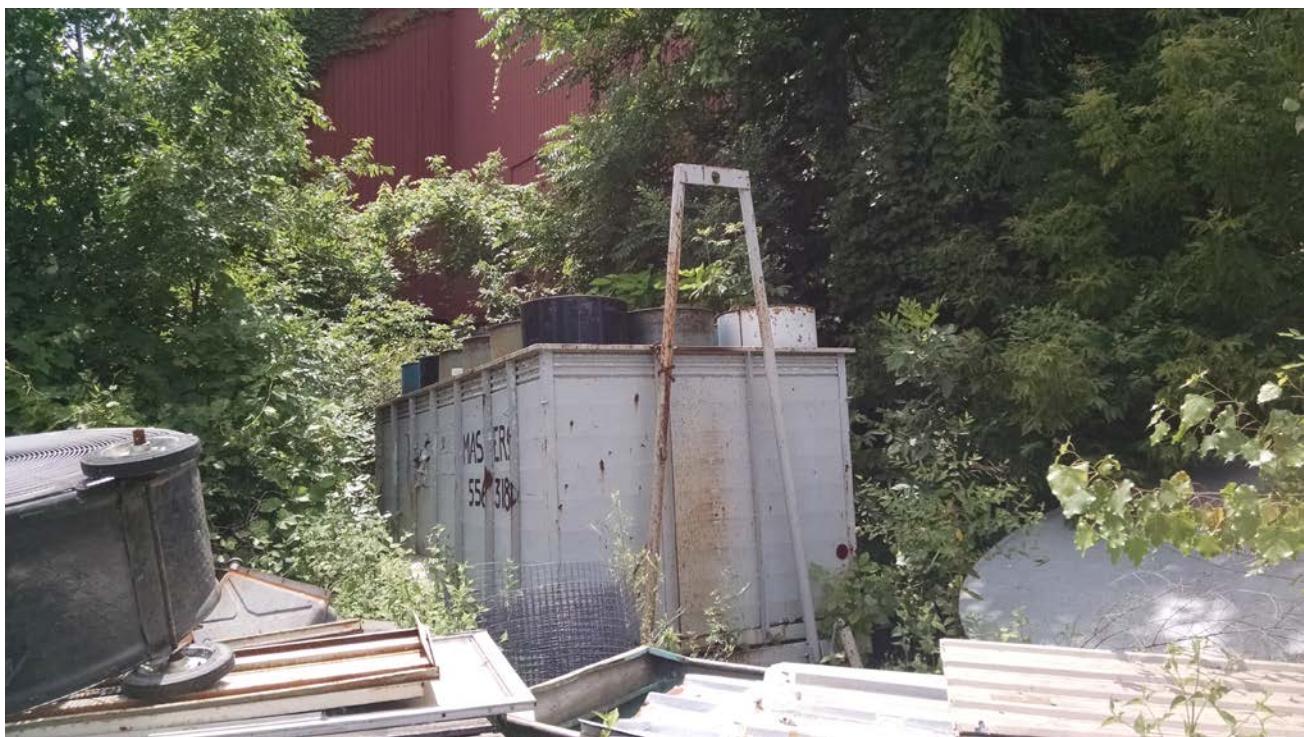
Photo 14 – View of sled full of unknown 55 gallon drums located on the grounds of the west side property.

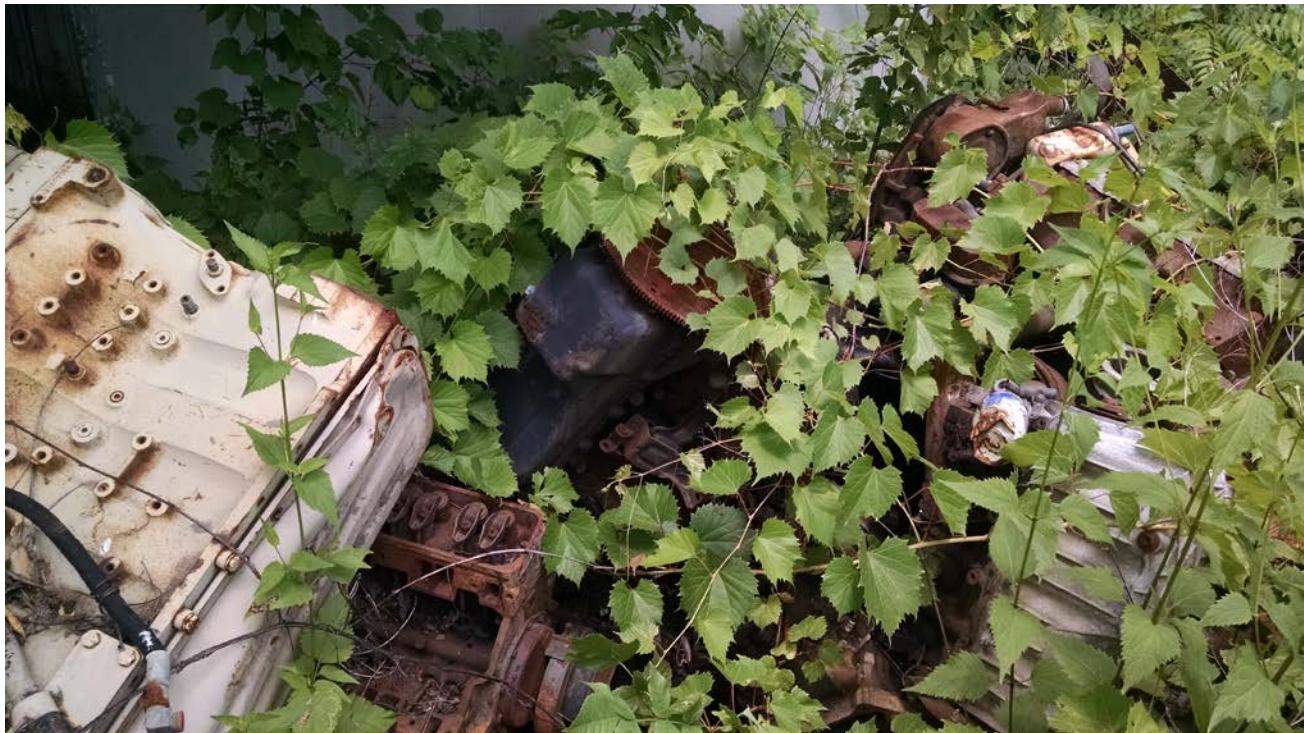
Photo 16 – View of leaking used motors located on the north side of the grounds of the west side property.

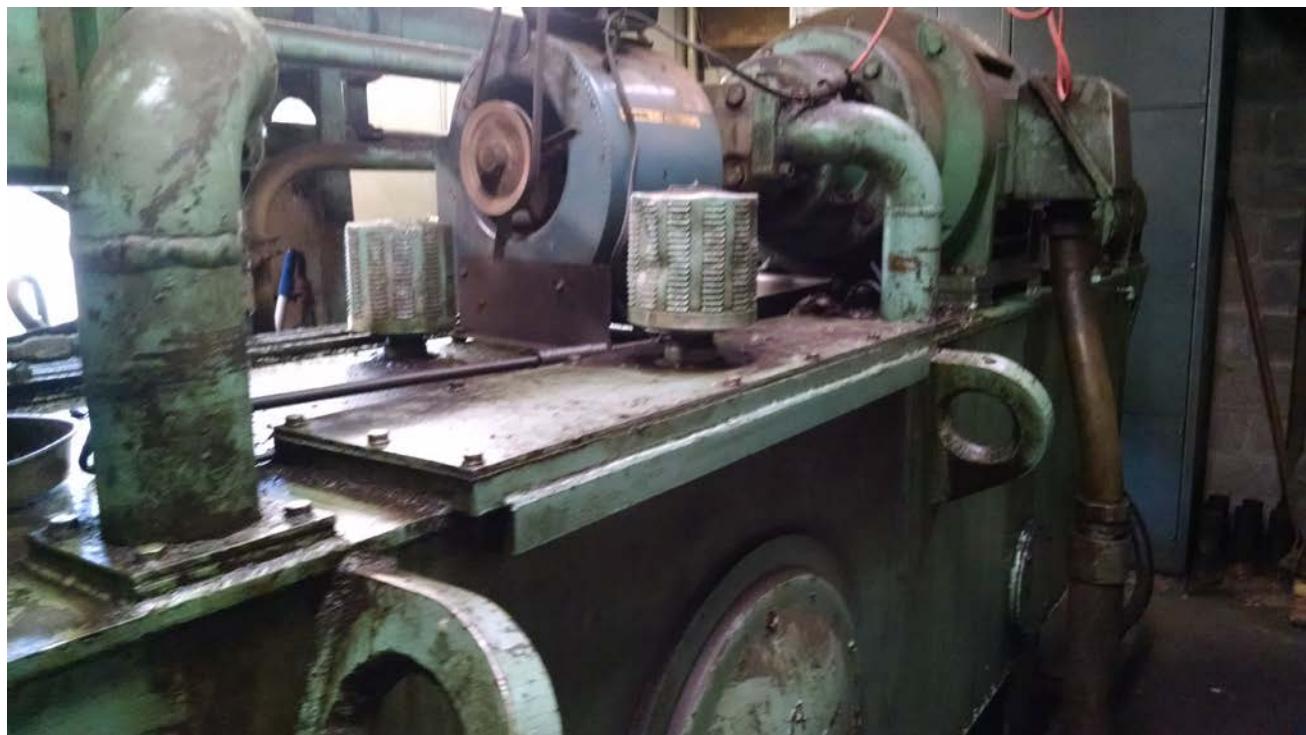
Photo 17 – View of inside the crusher control building located on the grounds of the west side property.

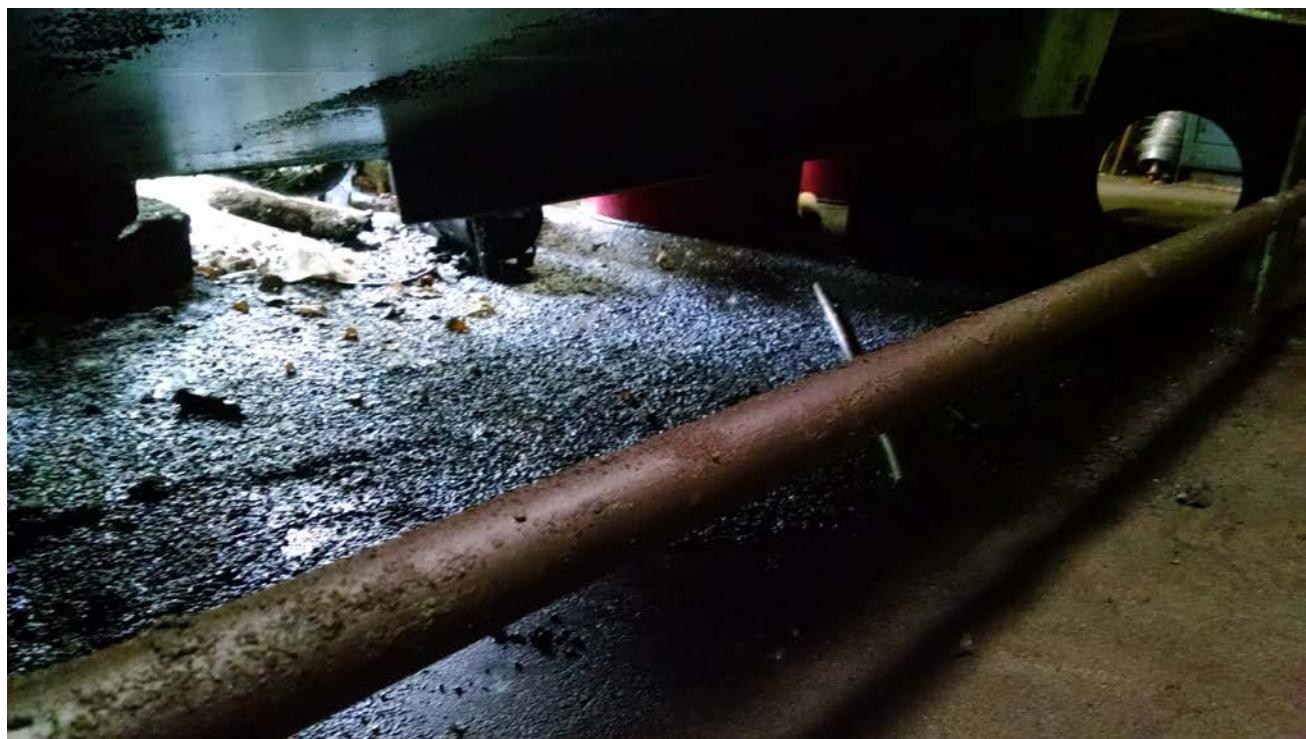
Photo 18 – View of staining under equipment located inside the control building on the grounds of the west side

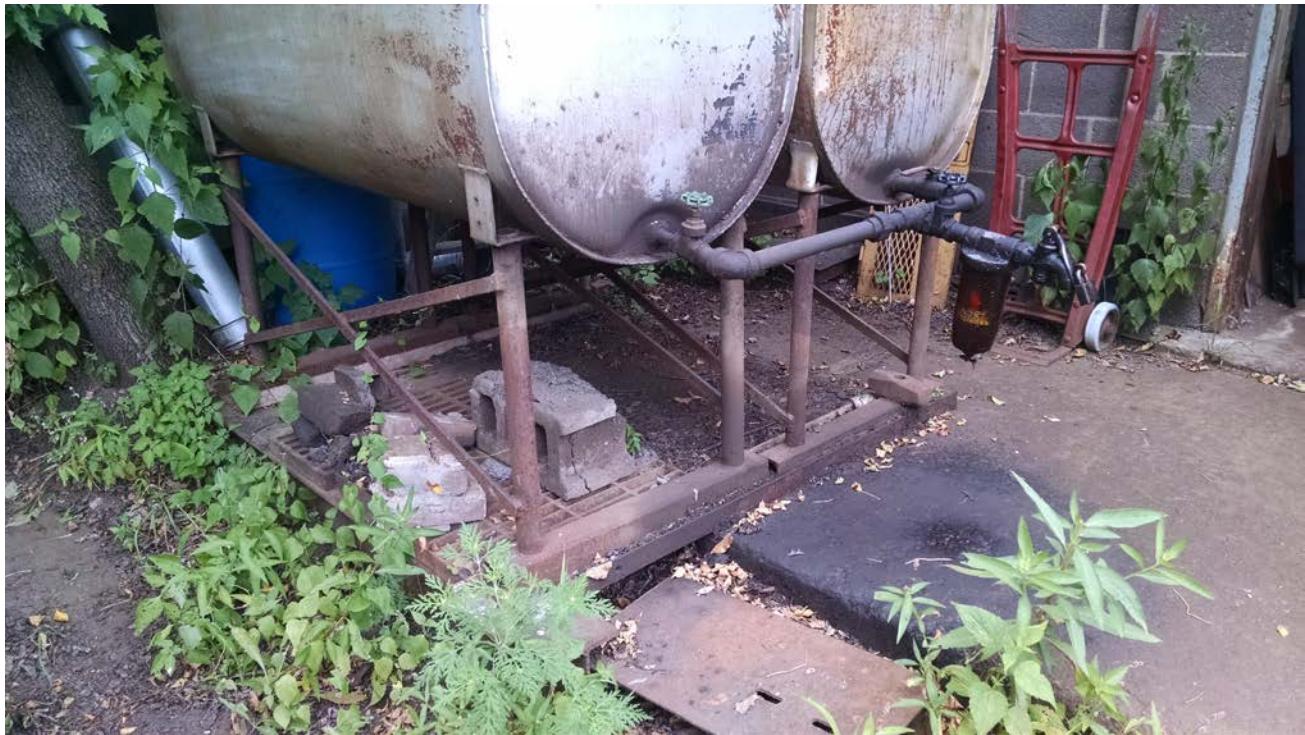
Photo 19 – View of two ASTs and staining located outside the control building on the grounds of the west side property.

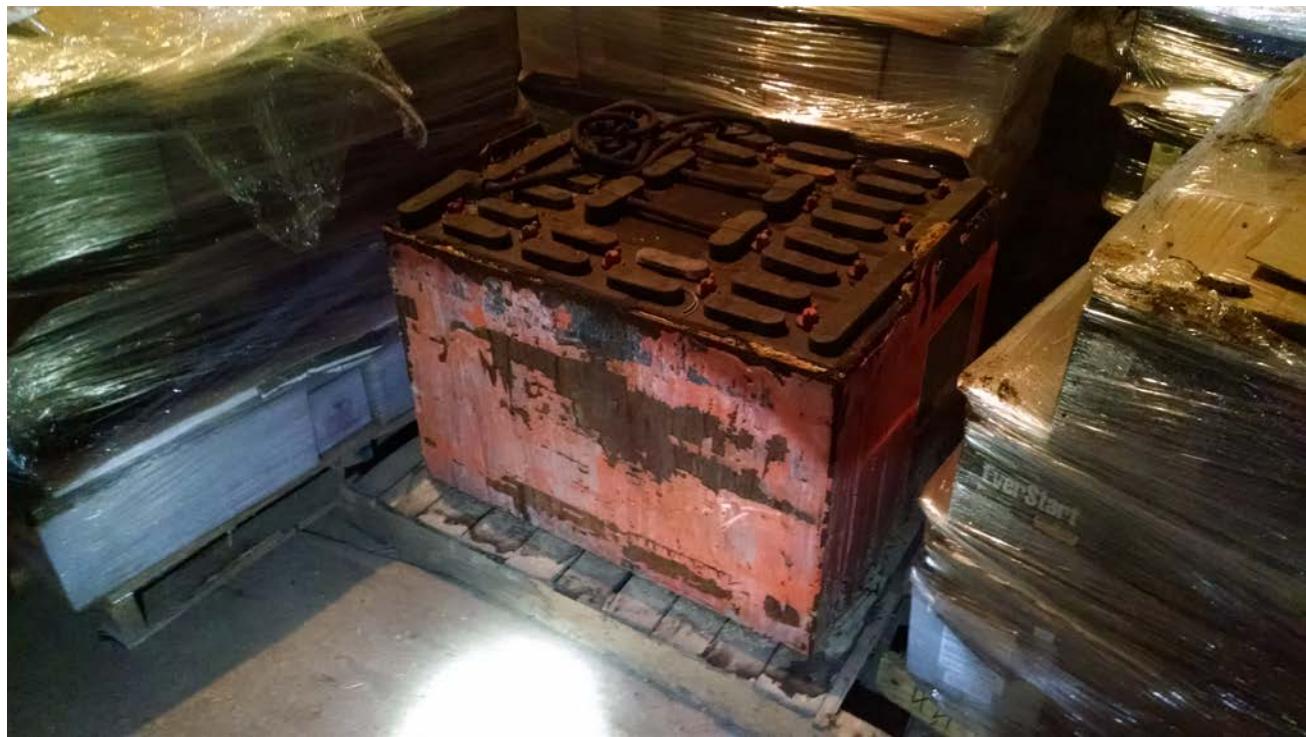
4. Throughout the site walk, HR Green observed several batteries. One large battery in particular was observed to be leaking onto the wood pallet it was placed on top of. This observation was located on the 501 E. 15th St. property (see photos 21 and 22). No visible secondary containment was present. Based on previous environmental site assessment records provided, this area has not been assessed for RCRA Metals or PCBs.

Photo 21 – View of staining under large battery located in the building on the east side property.

- Obtain samples from areas containing potential lead and other metal contamination. These areas include, but are not limited to, the soil surrounding the smelter/incinerator equipment and battery storage area of the 501 E. 15th St. property.

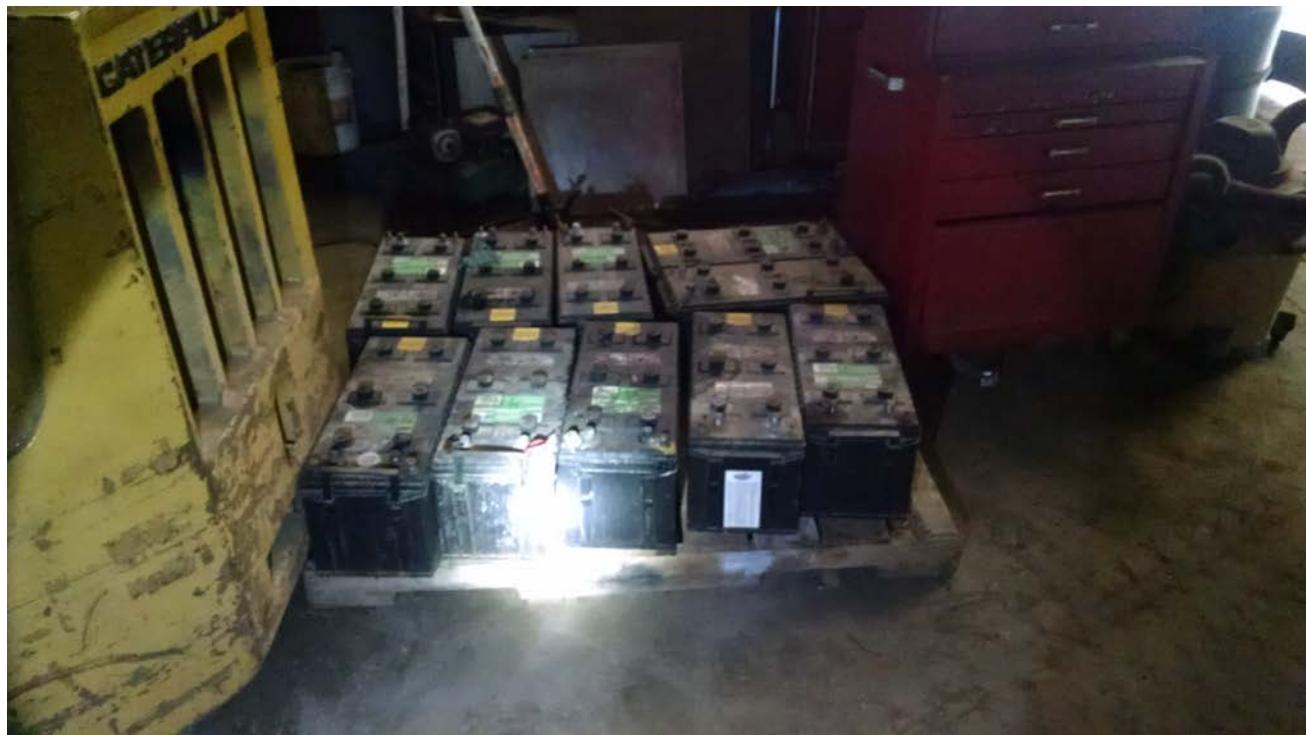
Photo 22 – View of pallet of batteries located in the building on the east side property.

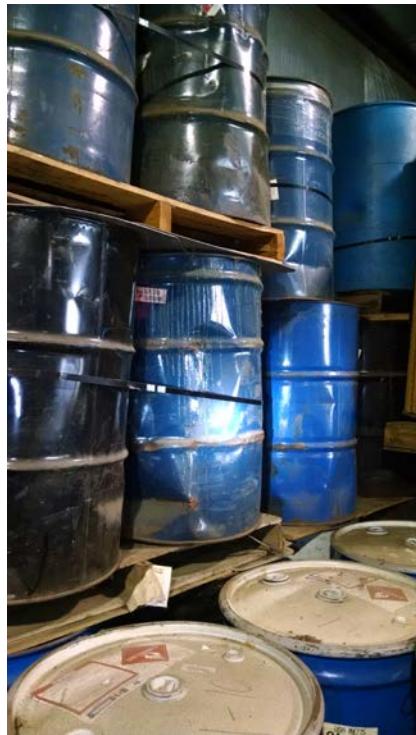
Photo 23 – View of 55-gallon drums labeled “contaminated Thermolyne” in the building on the east side property. Mr. Blum explained this as an industry term, rather than being indicative of environmental contamination

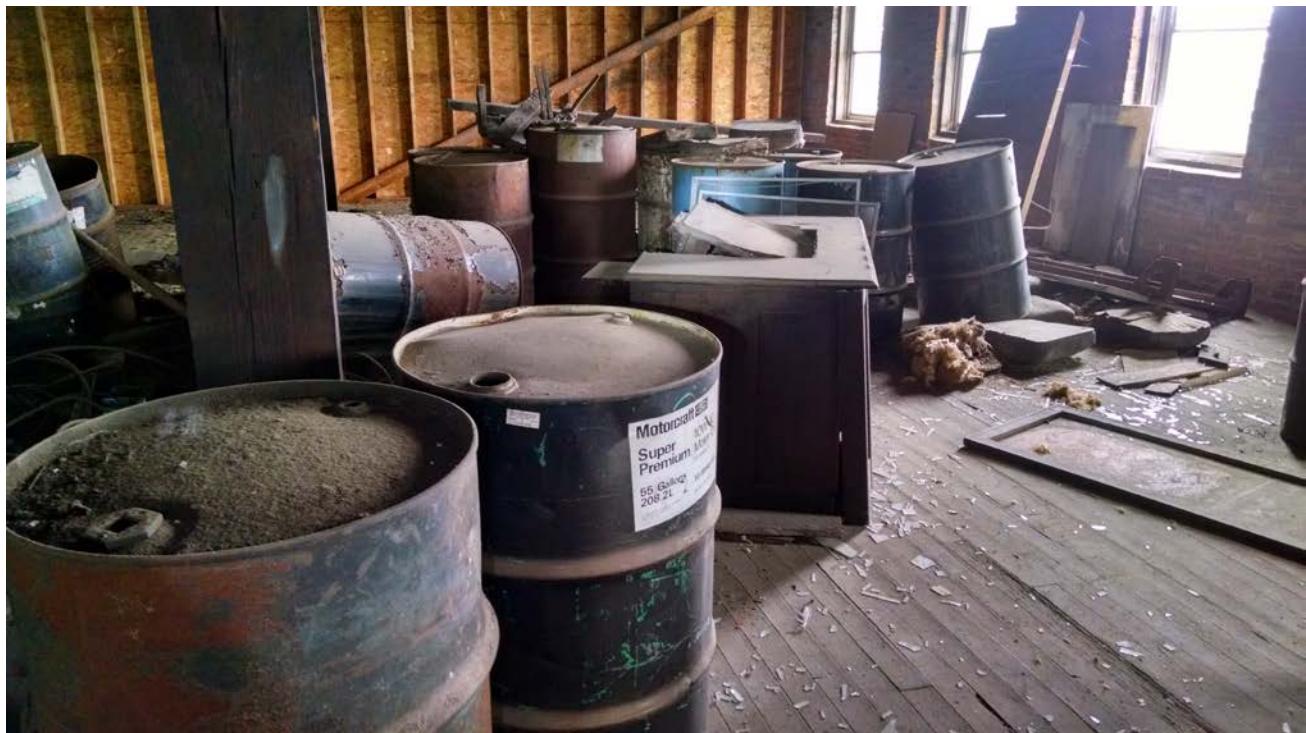
Photo 26 – View of 55-gallon drums located on the second floor of the building on the west side property.

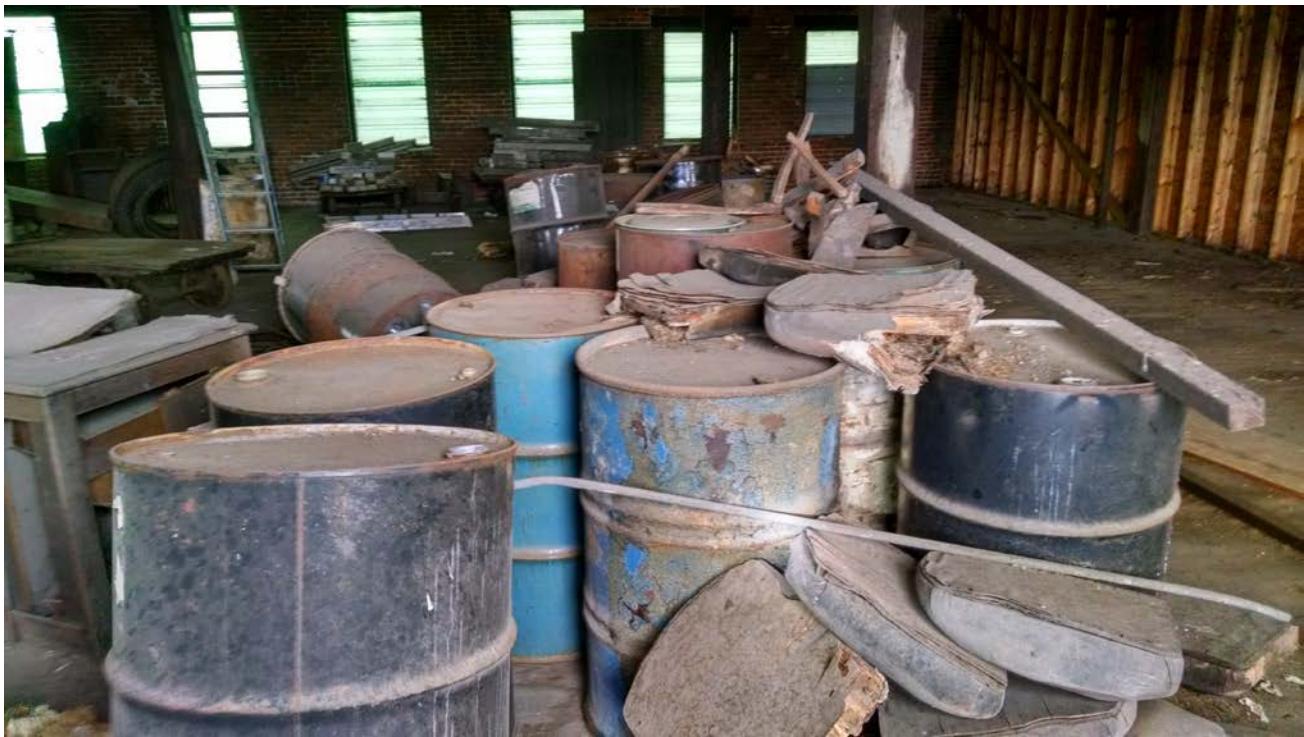
Photo 27 – View of 55-gallon drums located on the second floor of the building on the west side property.

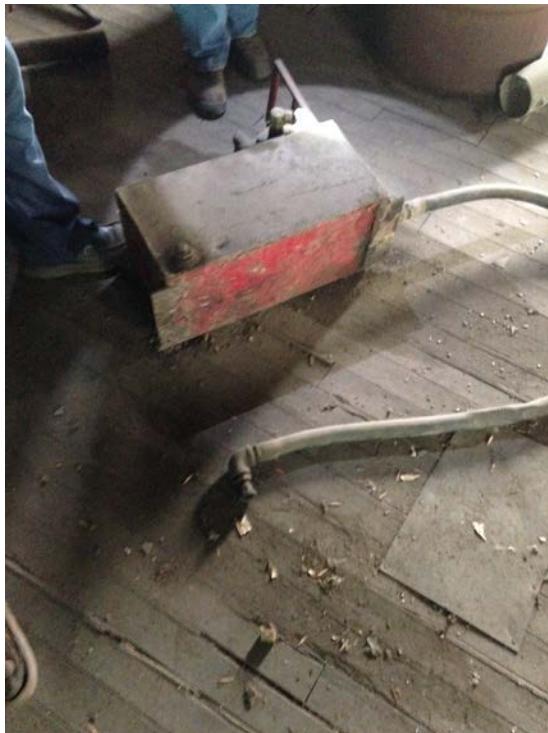
Photo 29 – View of staining located under a piece of equipment on the second floor of the building on the west side property.

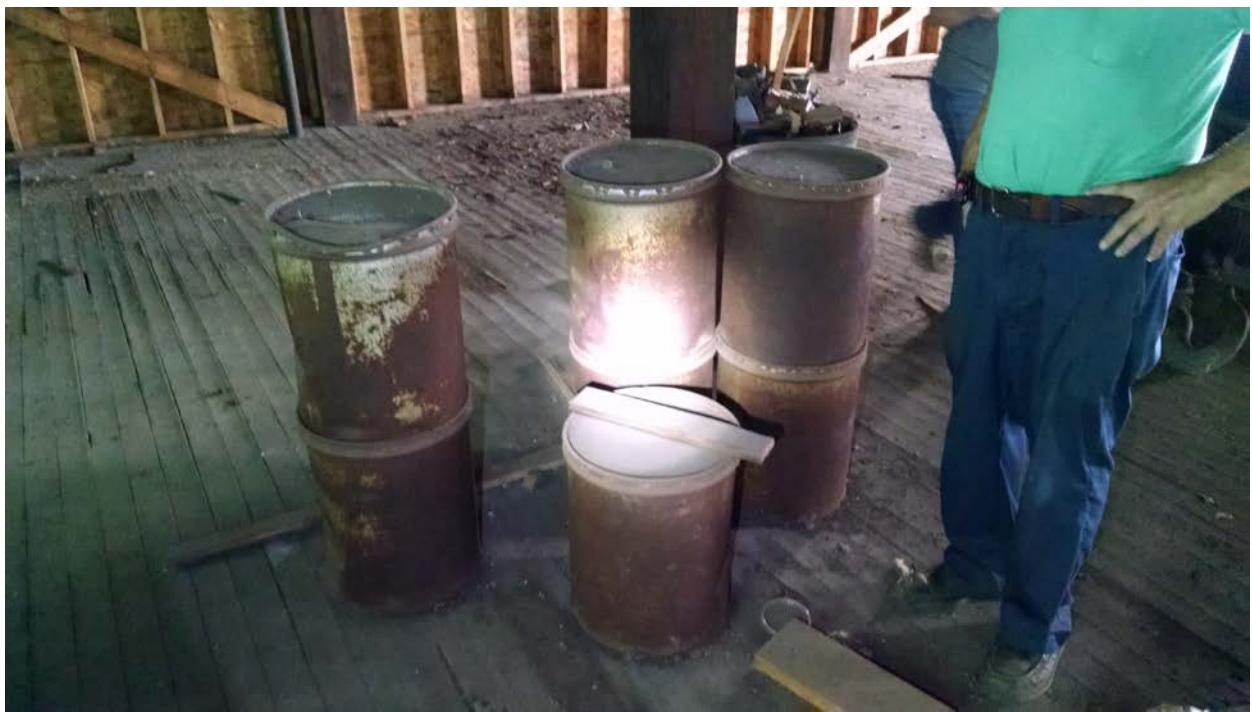
Photo 30 – View of 5-gallon containers located in the building on the west side property (contents unknown).

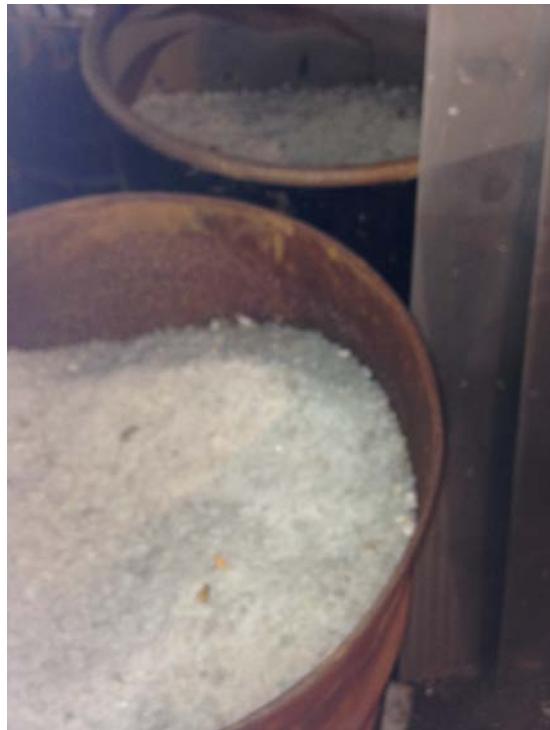
Photo 31 – View of colloidal silica located in several locations in the main office building on the subject property.

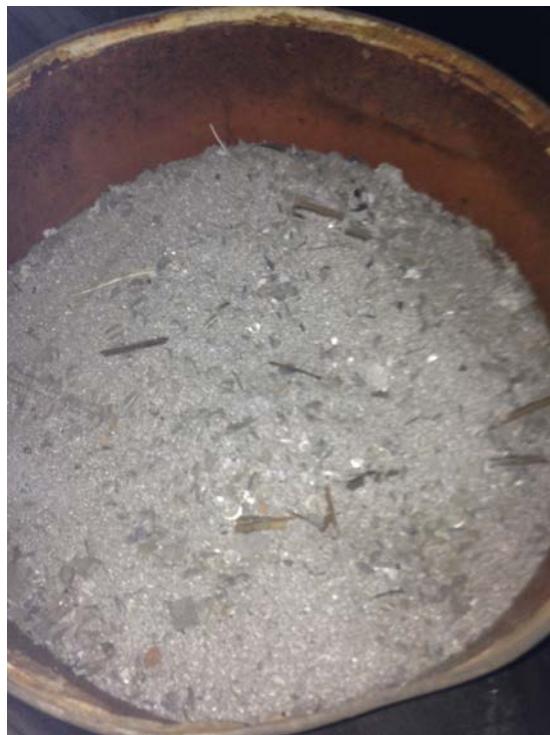
Photo 32 – View of steel slag located in several locations on the subject property.

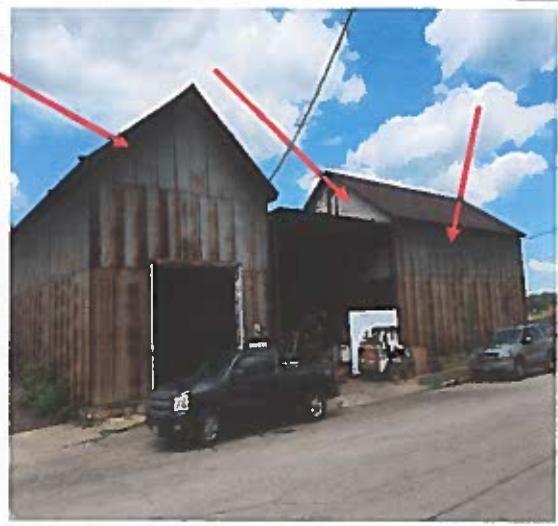
D-3: Transite siding under metal, top half of buildings.

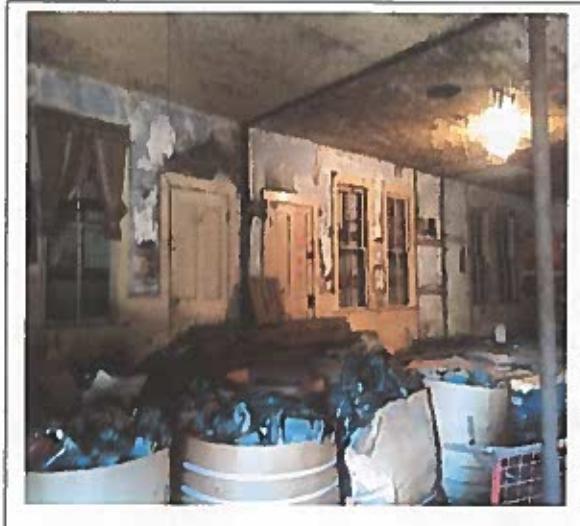
D-13: Window glazing, building 3 (towards river)
