# **ASBESTOS INSPECTION REPORT**

Commercial Building

501 East 15<sup>th</sup> St.

Project #: Y20715W

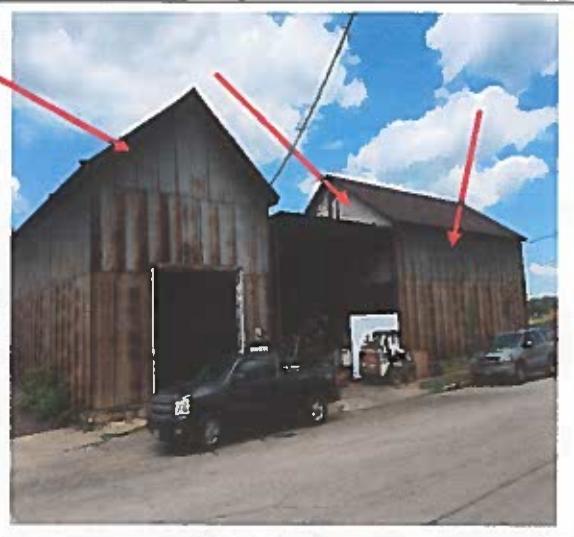
#1: Transite is on both building one and three under metal. Appears to be only on the top half of the building.

D-3: Transite siding under metal, top half of buildings.

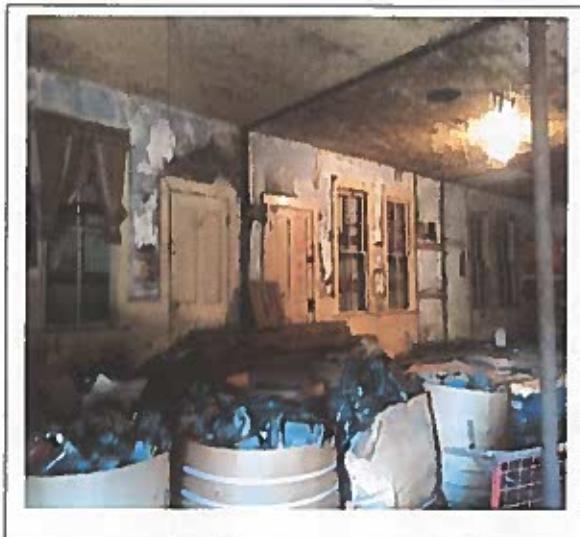
D-13: Window glazing, building 3 (towards river)

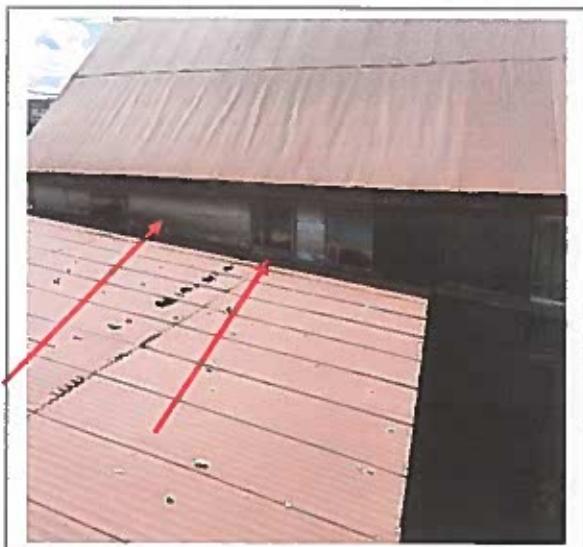
D-17: Tar on lean to flashing to building one and three.

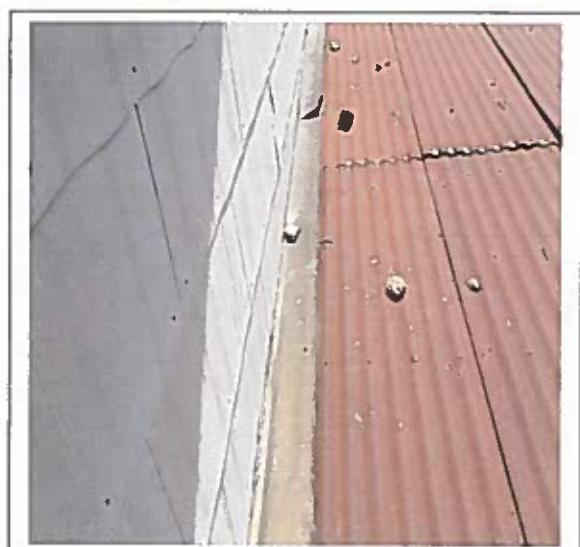
D-17: Tar on lean to flashing to building 3, on metal and transite
