# **ASBESTOS INSPECTION REPORT**

**INSPECTION ADDRESS:**  
**Blum Properties, West Buildings**  
**Corner of Elm and 15<sup>th</sup> St.**  
**Dubuque, IA 52001**  
**Project #: Z21857W**

**Advanced Environmental Testing and Abatement**

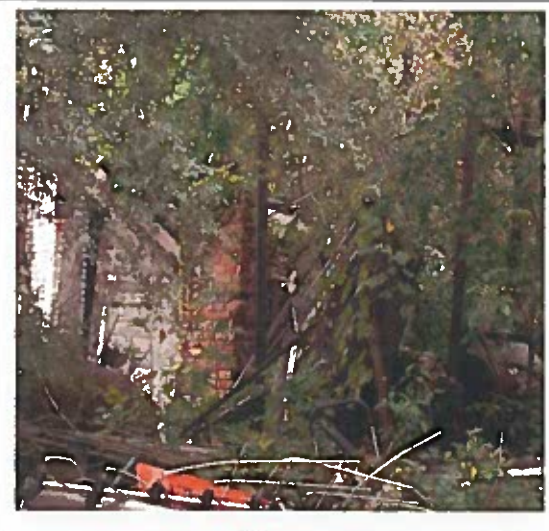
Building not inspected, Half collapsed and no access

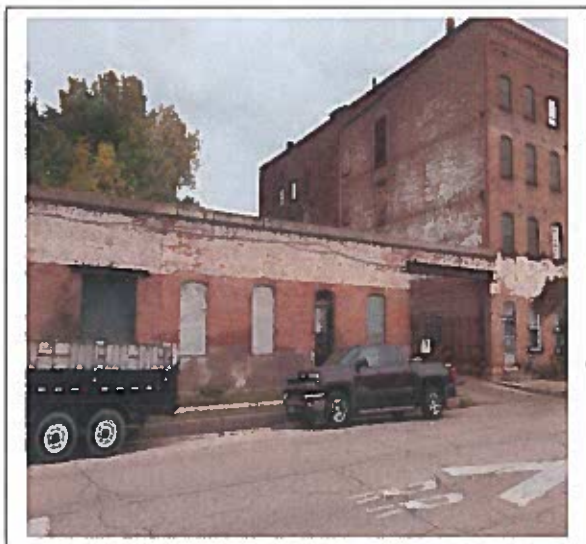
**Collapsed building on 15<sup>th</sup> St. One story remaining of the original four story building.**

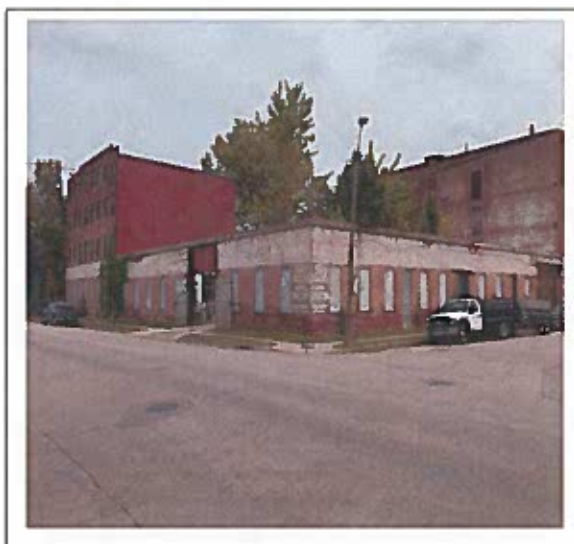
**Remaining front and side walls of building torn down years ago. Window glazing positive on Elm St Windows North of wall opening to scrap yard.**

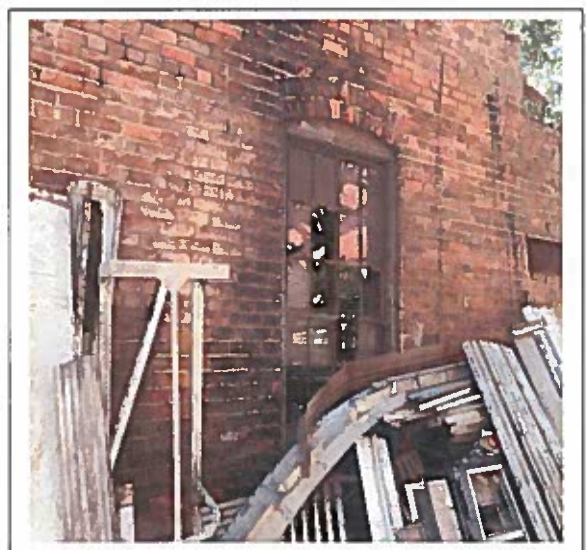
| Sample Number | Material | Color | Locations | Quantity | ACM% |
|---|---|---|---|---|---|
| A-3 | Glazing | White | Exterior windows | 1 window plus debris in other windows | 3% Chry. |

**A-3: Window glazing collapsed building.**

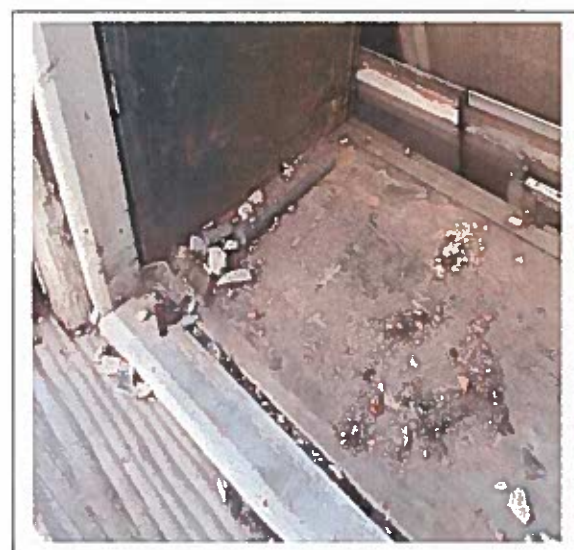
**A-3: Window glazing debris in window sills of collapsed building. Windows gone except one window.**

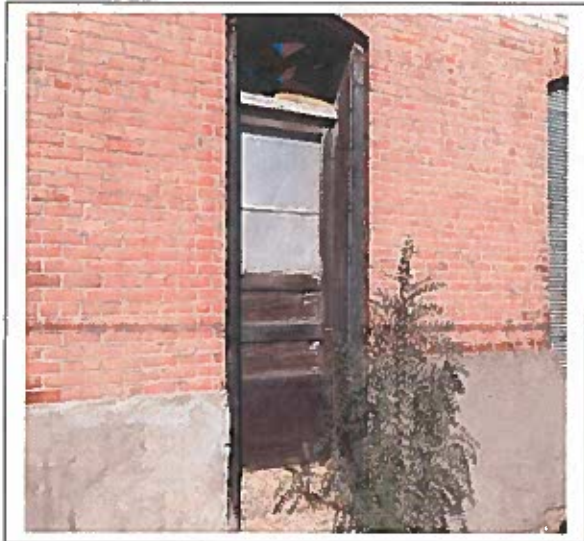
| Sample Number | Material | Color | Locations | Quantity | ACM% |
|---|---|---|---|---|---|
| A-9 | Caulking | White | Side door, 15 <sup>th</sup> St side | 1 Each | 3% Chry. |

A-9: Caulking around Elm St. door, wood frame to brick.

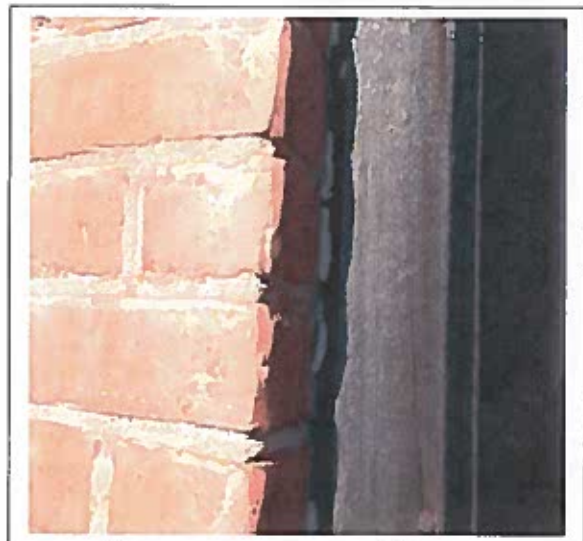
A-9 Caulking around Elm St. door, close up picture.

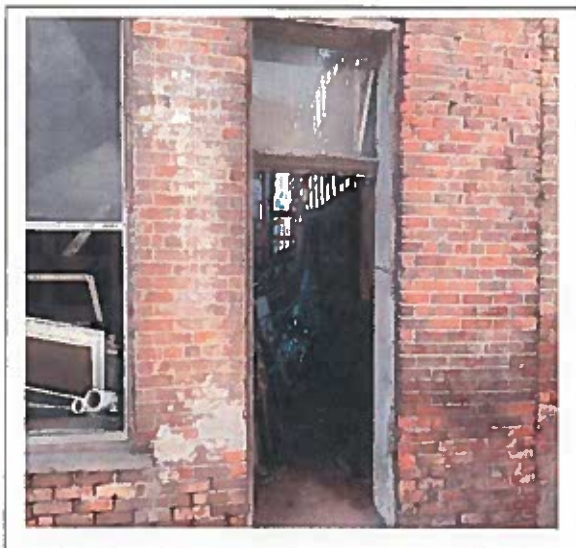
| Sample Number | Material | Color | Locations | Quantity | ACM% |
|---|---|---|---|---|---|
| A-10 | Caulking | Black | Scale house side, side door | 1 Each | 8% Chry. |

A-10: Black caulking around scale house side, side door of collapsed building. Caulking frame to brick.

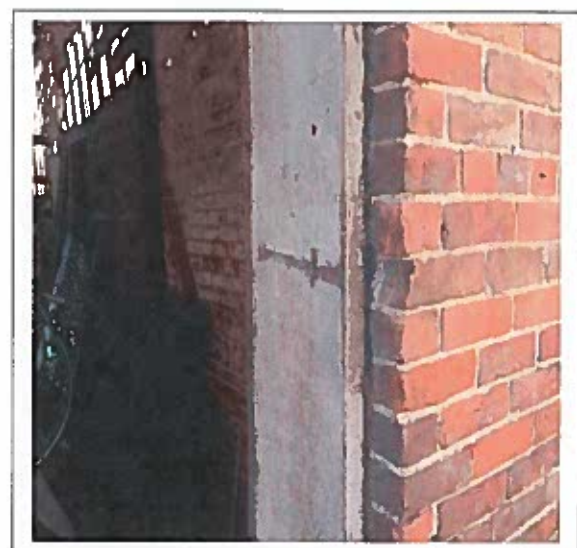
A-10: Close up view.

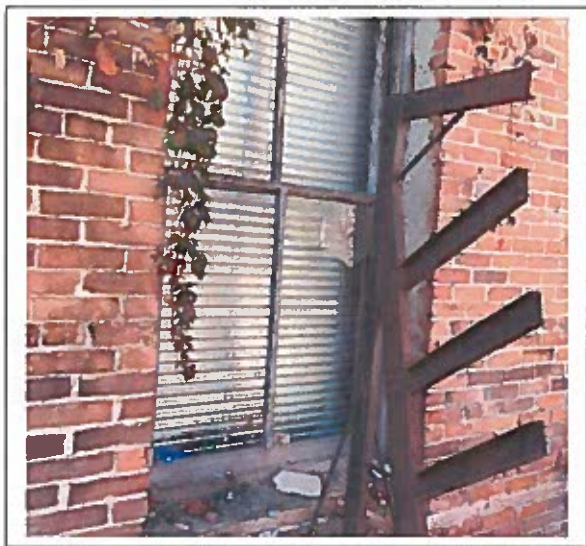
| Sample Number | Material | Color | Locations | Quantity | ACM% |
|---|---|---|---|---|---|
| A-15 | Glazing | White | Old wood windows | 5 Each | 3% Chry. |

**A-15:** Window glazing, old wood frames along Elm Street wall, covered by metal on the outside of the building.

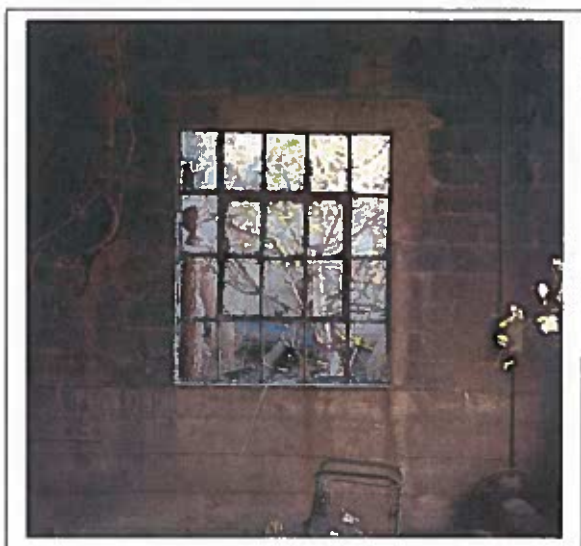
| Sample Number | Material | Color | Locations | Quantity | ACM% |
|---|---|---|---|---|---|
| A-18/19 | Glazing | White | Exterior windows | 3 Each | 3% Chry. |

**A-18/19:** Window glazing exterior windows of collapsed boiler building.

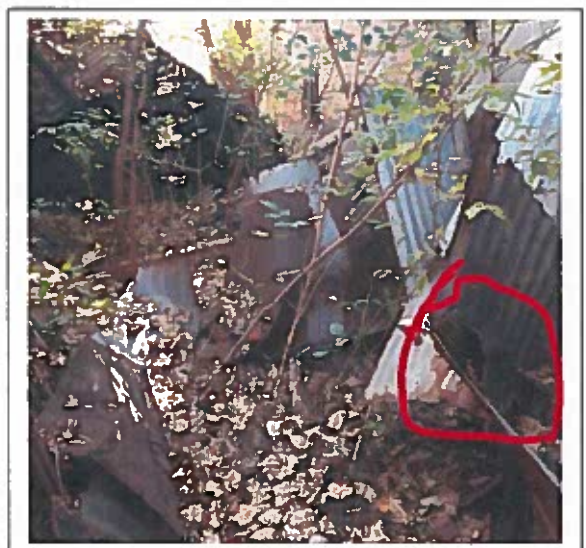
| Sample Number | Material | Color | Locations | Quantity | ACM% |
|---|---|---|---|---|---|
| A-20/20A | Roofing | Black | South part of building | 600 Sq. Ft. | 2-8% Chry. |

**A-20/20A:** Roof on south portion of boiler building. Debris throughout area.

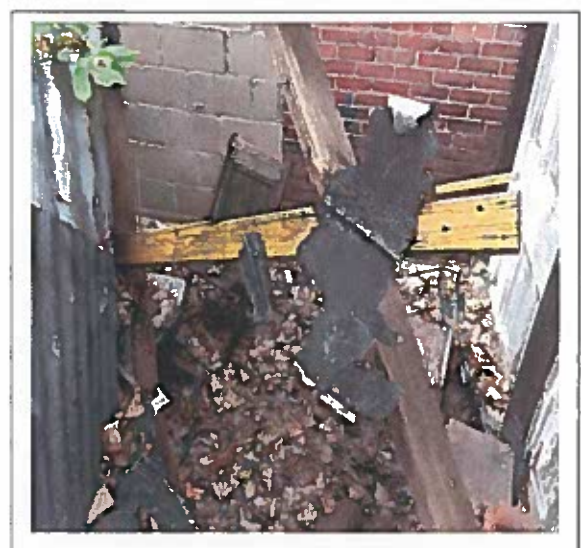
**A-20/20A:** Roofing debris throughout south portion of the building.

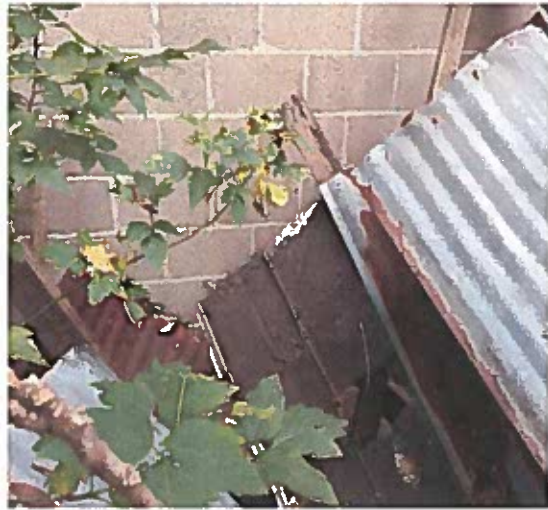
**A-20/20A: Roofing debris from south portion of building**

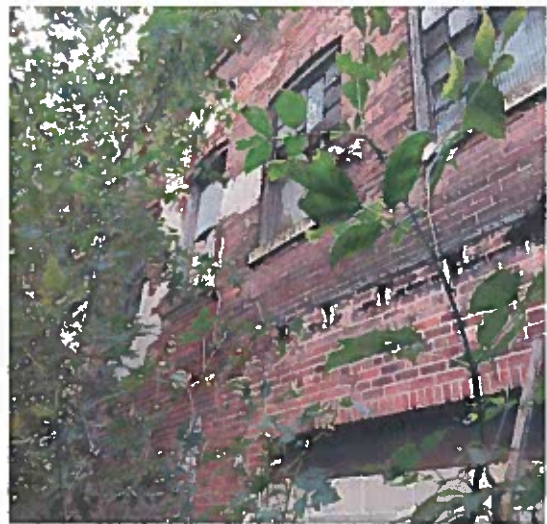
| Sample Number | Material | Color | Locations | Quantity | ACM% |
|---|---|---|---|---|---|
| A-21/22 | Tar | Black | Flashing on brick/Elm St. building | 60 Sq. Ft. | 10% Chry |

**A-21/22: Flashing tar on Elm St. building from collapsed boiler building.**

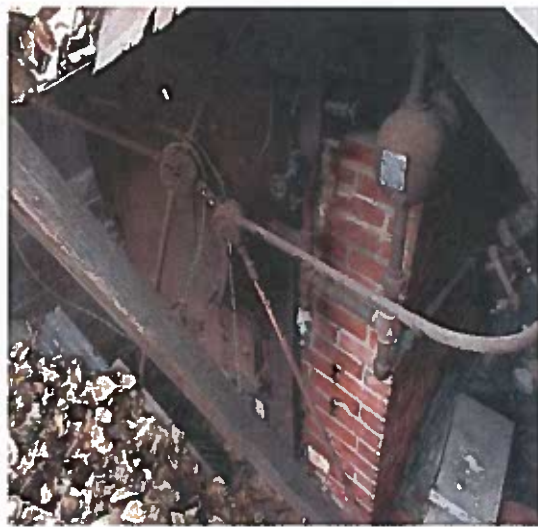
2. Boiler inside the collapsed building, east of the Elm St. four story building was not inspected due to building condition.

**Boiler in building not inspected. Roof collapsed on top of boiler. Will need to be inspected prior to demolition**

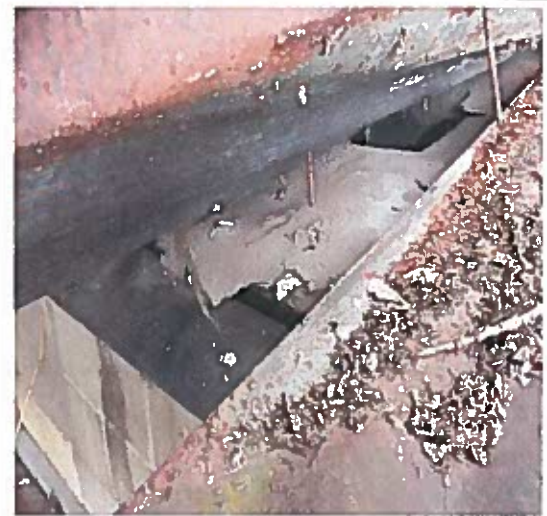
| Sample Number | Material | Color | Locations | Quantity | ACM% |
|---|---|---|---|---|---|
| A-23 | Tar paper | Black | Under metal, North section | 500 Sq. Ft. | 5% Chry. |

**A-23: Tar paper from north section of collapsed building with boiler.**

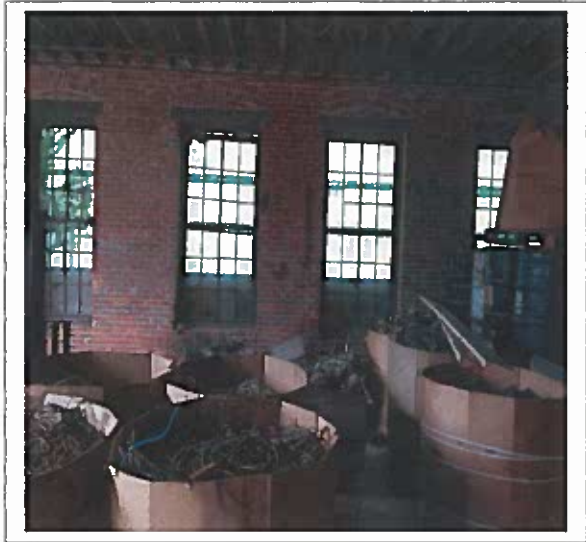
| Sample Number | Material | Color | Locations | Quantity | ACM% |
|---|---|---|---|---|---|
| A-28 | Glazing | White | Older wood windows | 13 Each | 3% Chry. |

A-28: Window glazing older windows throughout Elm St. building

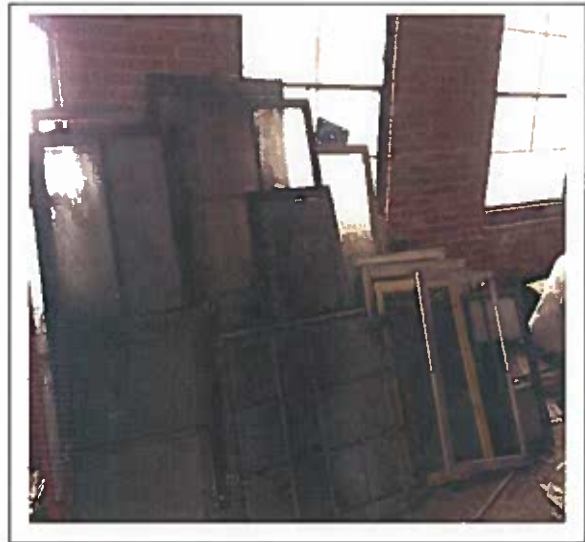
7. Windows in storage in the Elm St. building are assumed positive for asbestos. There are approximately 50 windows in storage on multiple floors throughout the building.

Stock piled windows with glazing, assumed positive.

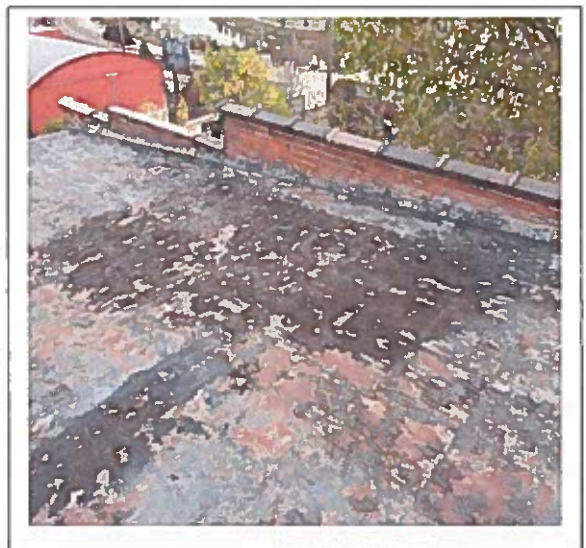
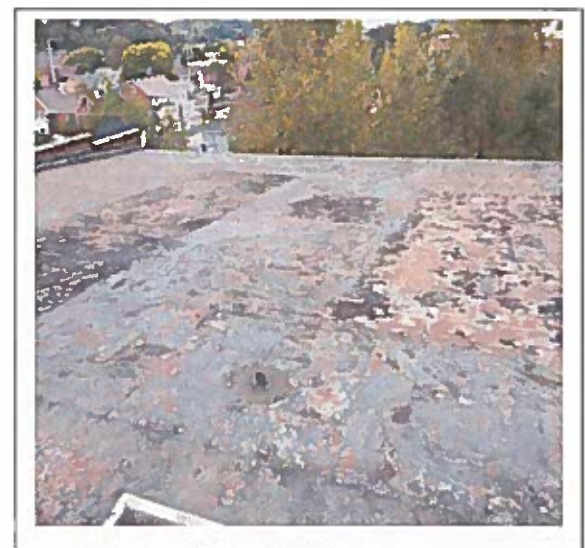
5. All tar on the Elm St. building roof should be all assumed asbestos. Lab results indicated both positive and negative samples

A-31, 32, 33, 35: Tar on metal roof, Elm st building.

A-31, 32, 33, 35: Tar on metal roof, Elm St. building.

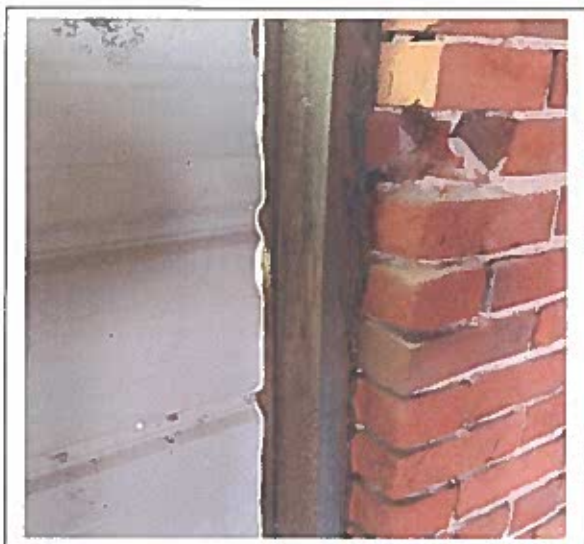
A-35: Caulking interior windows (mainly 4<sup>th</sup> floor) wood frame to brick Elm St. building.

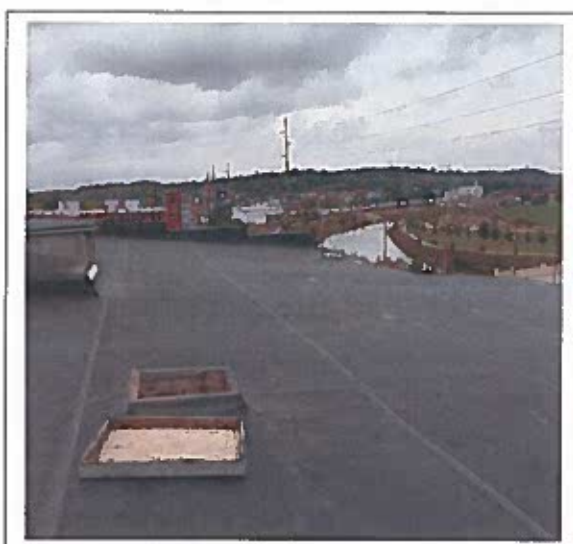
| Sample Number | Material | Color | Locations | Quantity | ACM% |
|---|---|---|---|---|---|
| A-49 | Field Roofing | Black | Roof | 8,500 Sq. Ft. | 5% Chry |

A-49: Roof on 15<sup>th</sup> St. building positive for asbestos under rubber roof.

6. Sample A-49, roofing field on the 15<sup>th</sup> St. building only the Silver layer tested positive for asbestos. It is recommended to treat all layers as asbestos containing.

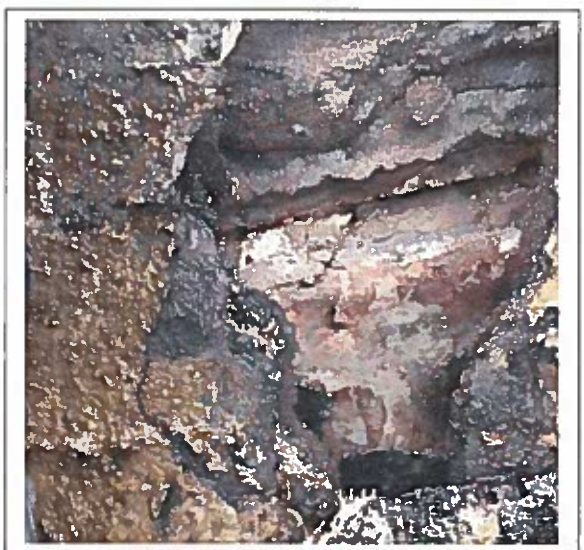
| Sample Number | Material | Color | Locations | Quantity | ACM% |
|---|---|---|---|---|---|
| A-51 | Flashing | Black | Parapet walls | 360 Sq. Ft. | 4% Chry. |
| A-54 | Tar | Black | Above flashing on parapet wall | 360 Sq. Ft. | 5-10 Chry. |

A-51: Flashing, parapet walls Elm St. building. A=54: Tar above flashing on parapet wall.

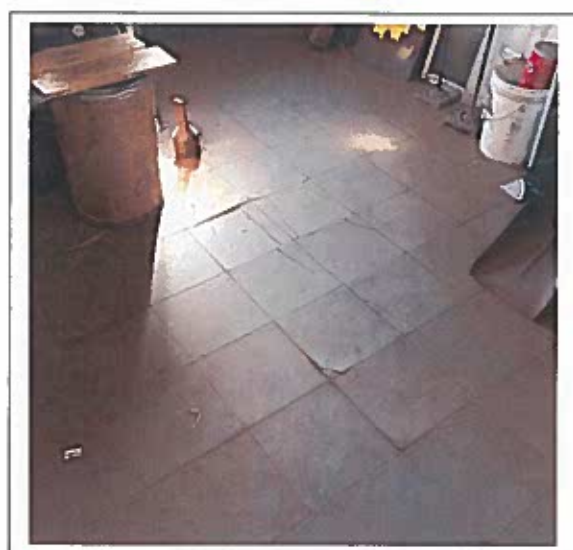
| Sample Number | Material | Color | Locations | Quantity | ACM% |
|---|---|---|---|---|---|
| A-70 | Tile | Black | Industrial tile front office | 600 Sq. Ft | 3-15% Chry. |
| A-71/72 | Floor tile and mastic | Brown | Under industrial tile | 600 Sq. Ft. | 5-10% Chry. |

A-70, 71, 73: Industrial tile front office and entry. 9x9 floor tile under industrial tile positive also. Mastic associated with tile positive
