Sewershed 11 Corrective Action Plan

Consent Decree No. 2:11-cv-01011-EJM

December 8, 2011

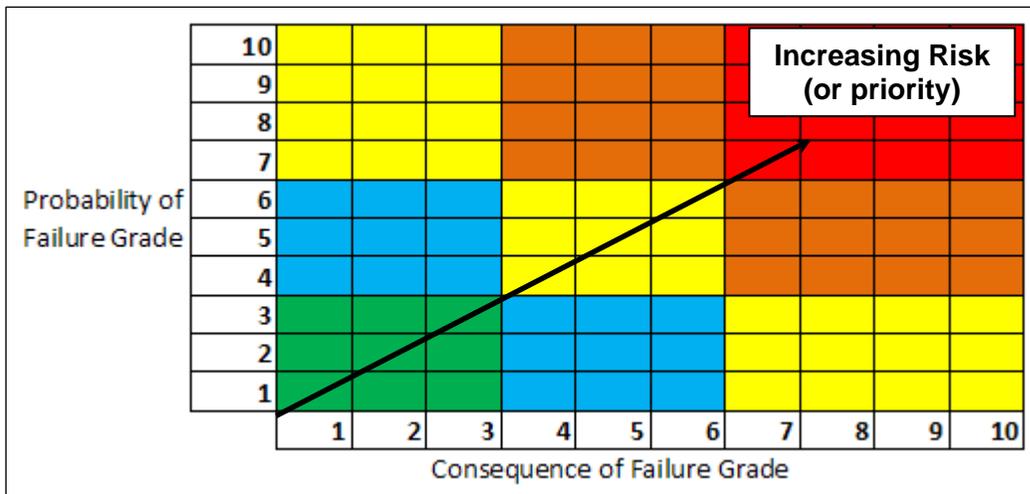
Figure 6-1. Criticality grade color matrix.

City staff developed a color matrix to determine an overall criticality grade (Figure 6-1) for each pipe. The color matrix is based off of the color matrix from the Pierce County, Washington Sewer Utility Asset Management Implementation Criticality Model. Each pipe was assigned a grade for the eleven factors mentioned above ranging from 0 to 10 – the higher the grade, the more critical the pipe is to the system. Probability of failure was assigned a greater emphasis because the City wants to locate pipes with the greatest risk of failure due to the pipe’s physical features. The grades associated with the color matrix are as follows:

- Red = 5
- Orange = 4
- Yellow = 3
- Blue = 2
- Green = 1.

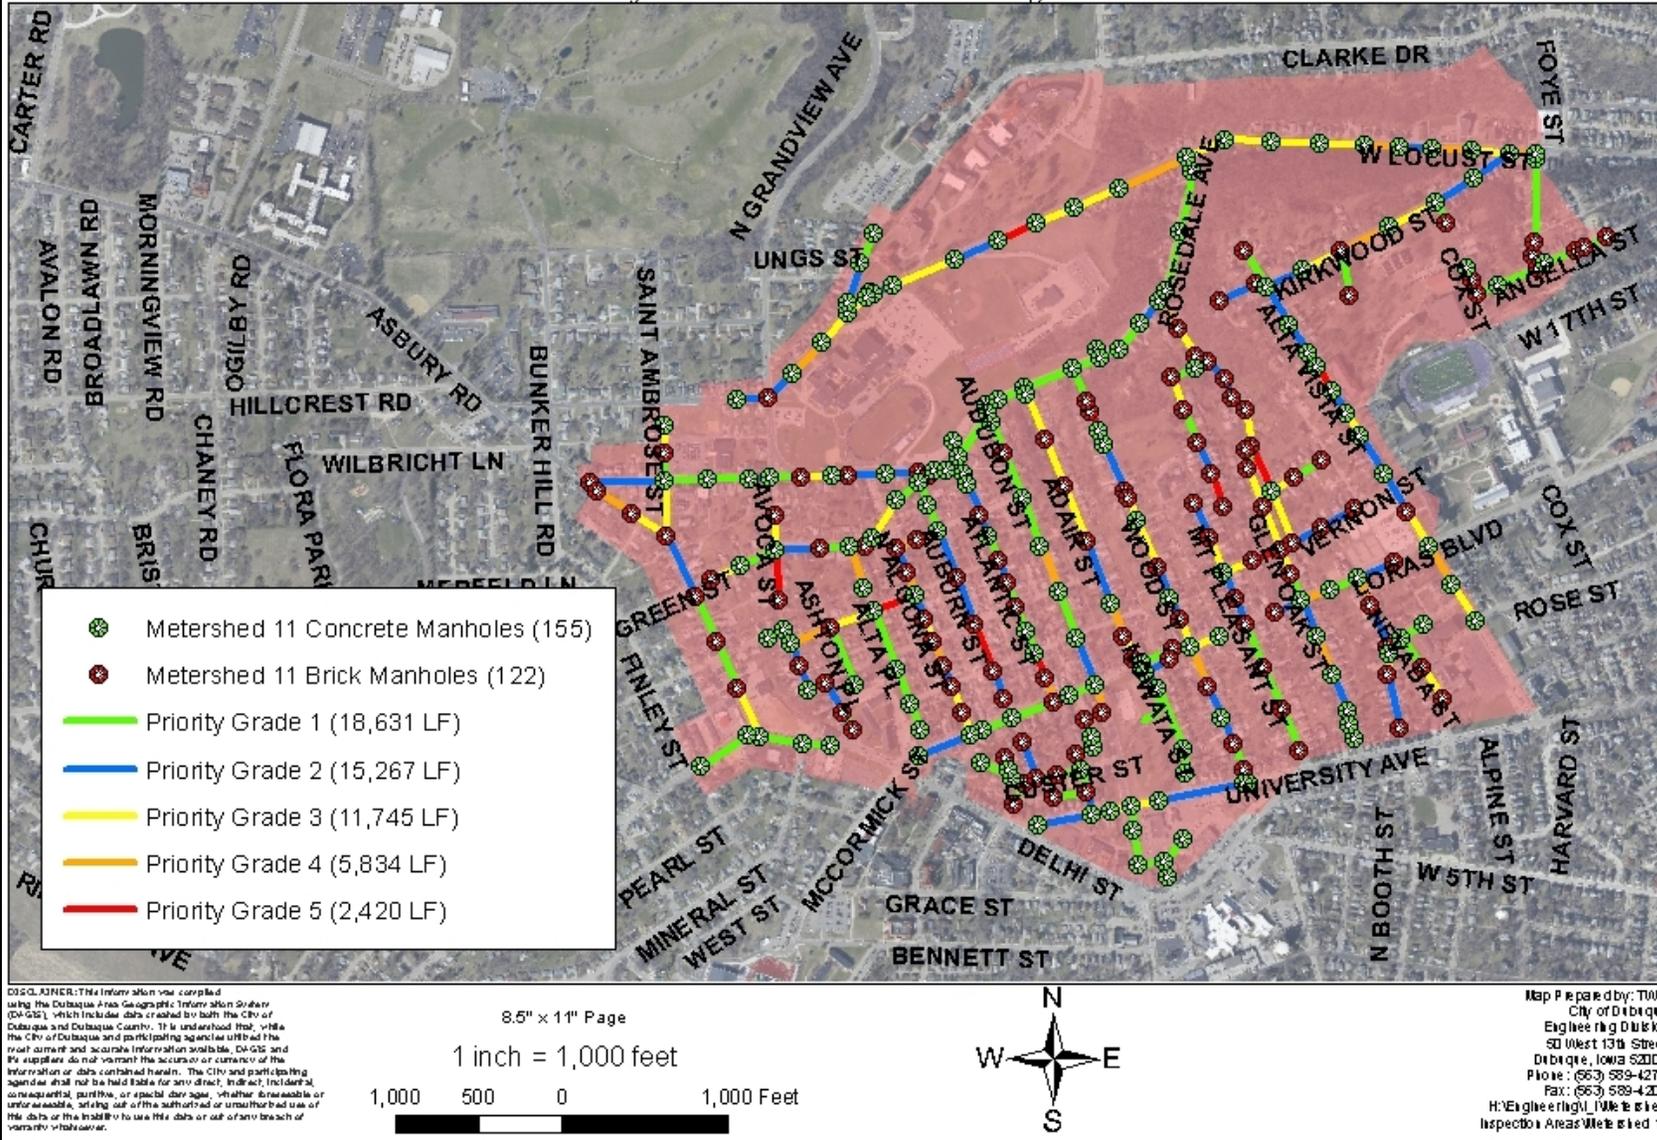
Figure 6-3. Priority grades and brick manholes.

Priority Grades and Brick Manholes (Figure 6-3)

Table 6-4 and Table 6-5 list the priority grade four and five pipes that have been identified for improvement or replacement. The City will begin improvement or replacement of the grade five pipes during 2012 and will continue with grade four pipes as needed until June 30, 2016. The cost to complete this work is approximately \$145,000.
