9 Preservation Briefs

National Park Service
U.S. Department of the Interior

The Repair of Historic Wooden Windows

John H. Myers

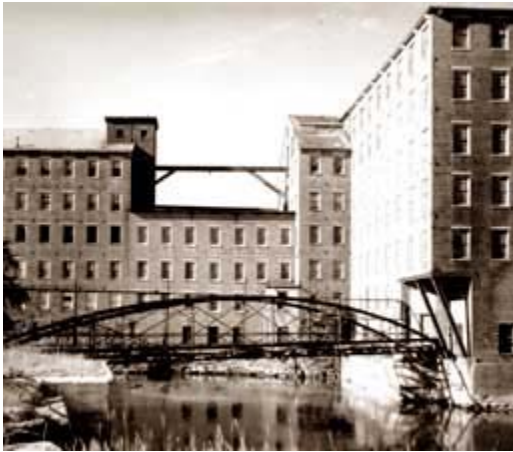
Windows are frequently important visual focal points, especially on simple facades such as this mill building. Replacement of the multi-pane windows with larger panes could dramatically alter the appearance of the building. Photo: NPS files.

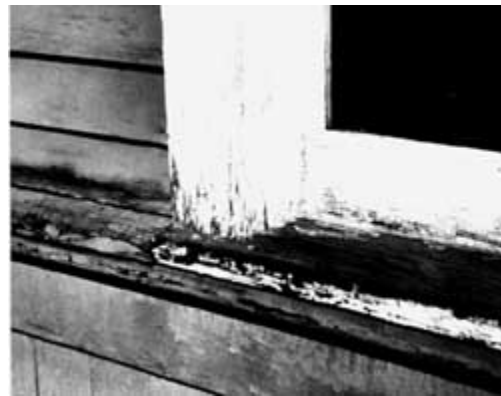
Deterioration of poorly maintained windows usually begins on horizontal surfaces and at joints, where water can collect and saturate the wood. Photo: NPS files.

Each window should be examined for operational soundness beginning with the lower portions of the frame and sash. Exterior rainwater and interior condensation can flow downward along the window, entering and collecting at points where the flow is blocked. The sill, joints between the sill and jamb, corners of the bottom rails and muntin joints are typical points where water collects and deterioration begins. The operation of the window (continuous opening and closing over the years and seasonal temperature changes) weakens the joints, causing movement and slight separation. This process makes the joints more vulnerable to water which is readily absorbed into the endgrain of the wood. If severe deterioration exists in these areas, it will usually be apparent on visual inspection, but other less severely deteriorated areas of the wood may be tested by two traditional methods using a small ice pick.

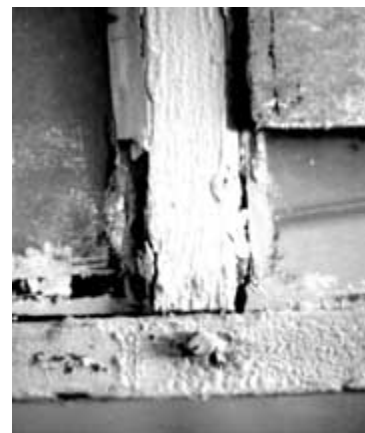
This historic double-hung window has many layers of paint, some cracked and missing putty, slight separation at the joints, broken sash cords, and one cracked pane. Photo: NPS files.

The routine maintenance required to upgrade a window to "like new" condition normally includes the following steps: 1) some degree of interior and exterior paint removal, 2) removal and repair of sash (including reglazing where necessary), 3) repairs to the frame, 4) weatherstripping and reinstallation of the sash, and 5) repainting. These operations are illustrated for a typical

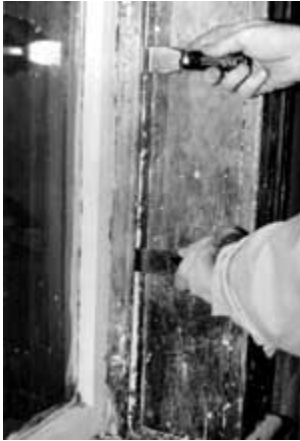
After removing paint from the seam between the interior stop and the jamb, the stop can be pried out and gradually worked loose using a pair of putty knives as shown. Photo: NPS files.

Paint removal should begin on the interior frames, being careful to remove the paint from the interior stop and the parting bead, particularly along the

seam where these stops meet the jamb. This can be accomplished by running a utility knife along the length of the seam, breaking the paint bond. It will then be much easier to remove the stop, the parting bead and the sash. The interior stop may be initially loosened from the sash side to avoid visible scarring of the wood and then gradually pried loose using a pair of putty knives, working up and down the stop in small increments. With the stop removed, the lower or interior sash may be withdrawn. The sash cords should be detached from the sides of the sash and their ends may be pinned with a nail or tied in a knot to prevent them from falling into the weight pocket.

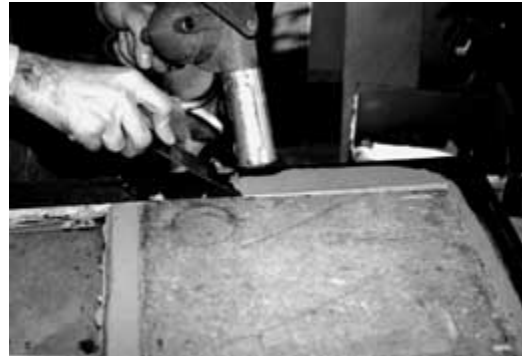
Sash can be removed and repaired in a convenient work area. Paint is being removed from this sash with a hot air gun. Photo: NPS files.

The sash can be stripped of paint using appropriate techniques, but if any heat treatment is used, the glass should be removed or protected from the sudden temperature change which can cause breakage. An overlay of aluminum foil on gypsum board or asbestos can protect the glass from such rapid temperature change. It is important to protect the glass because it may be historic and often adds character to the window. Deteriorated putty should be removed manually, taking care not to damage the wood along the rabbet. If the glass is to be removed, the glazing points which hold the glass in place can be extracted and the panes numbered and removed for cleaning and reuse in the same openings. With the glass panes out, the remaining putty can be removed and the sash can be sanded, patched, and primed with a preservative primer. Hardened putty in the rabbets may be softened by heating with a soldering iron at the

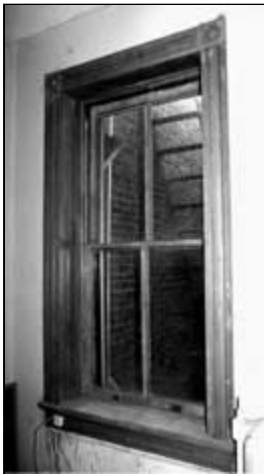
Following the relatively simple repairs, the window is weathertight, like new in appearance, and serviceable for many years to come. Photo: NPS files.

The operations just discussed summarize the efforts necessary to restore a window with minor deterioration to "like new" condition. The techniques can be applied by an unskilled person with minimal training and experience. To demonstrate the practicality of this approach, and photograph it, a Technical Preservation Services staff member repaired a wooden double-hung, two over two window which had been in service over ninety years. The wood was structurally sound but the window had one broken pane, many layers of paint, broken sash cords and inadequate, worn-out weatherstripping. The staff member found that the frame could be stripped of paint and the sash removed quite easily. Paint, putty and glass removal required about one hour for each sash, and the reglazing of both sash was accomplished in about one hour. Weatherstripping of the sash and frame, replacement of the sash cords and reinstallation of the sash, parting bead, and stop required an hour and a half. These times refer only to individual operations; the entire process took several days due to the drying and curing times for putty, primer, and paint, however, work on other window units could have been in progress during these lag times.

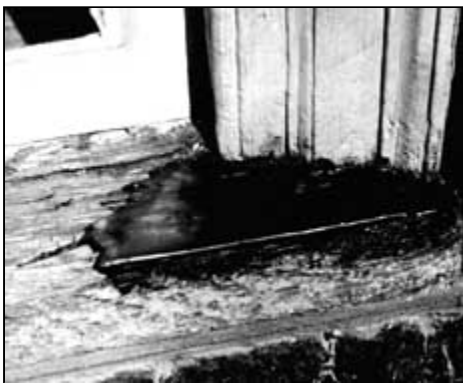
This illustrates a two-part epoxy patching compound used to fill the surface of a weathered sill and rebuild the missing edge. When the epoxy cures, it can be sanded smooth and painted to achieve a durable and waterproof repair. Photo: NPS files.

Wood may also be strengthened and stabilized by consolidation, using semirigid epoxies which saturate the porous decayed wood and then harden. The surface of the consolidated wood can then be filled with a semirigid epoxy patching compound, sanded and painted. Epoxy patching compounds can be used to build up missing sections or decayed ends of members. Profiles can be duplicated using hand molds, which are created
